December 21, 2016

Re: Annual CCR Landfill Inspection Report for 2016
R.D. Morrow, Sr. Power Generating Station
Purvis, Lamar County, Mississippi

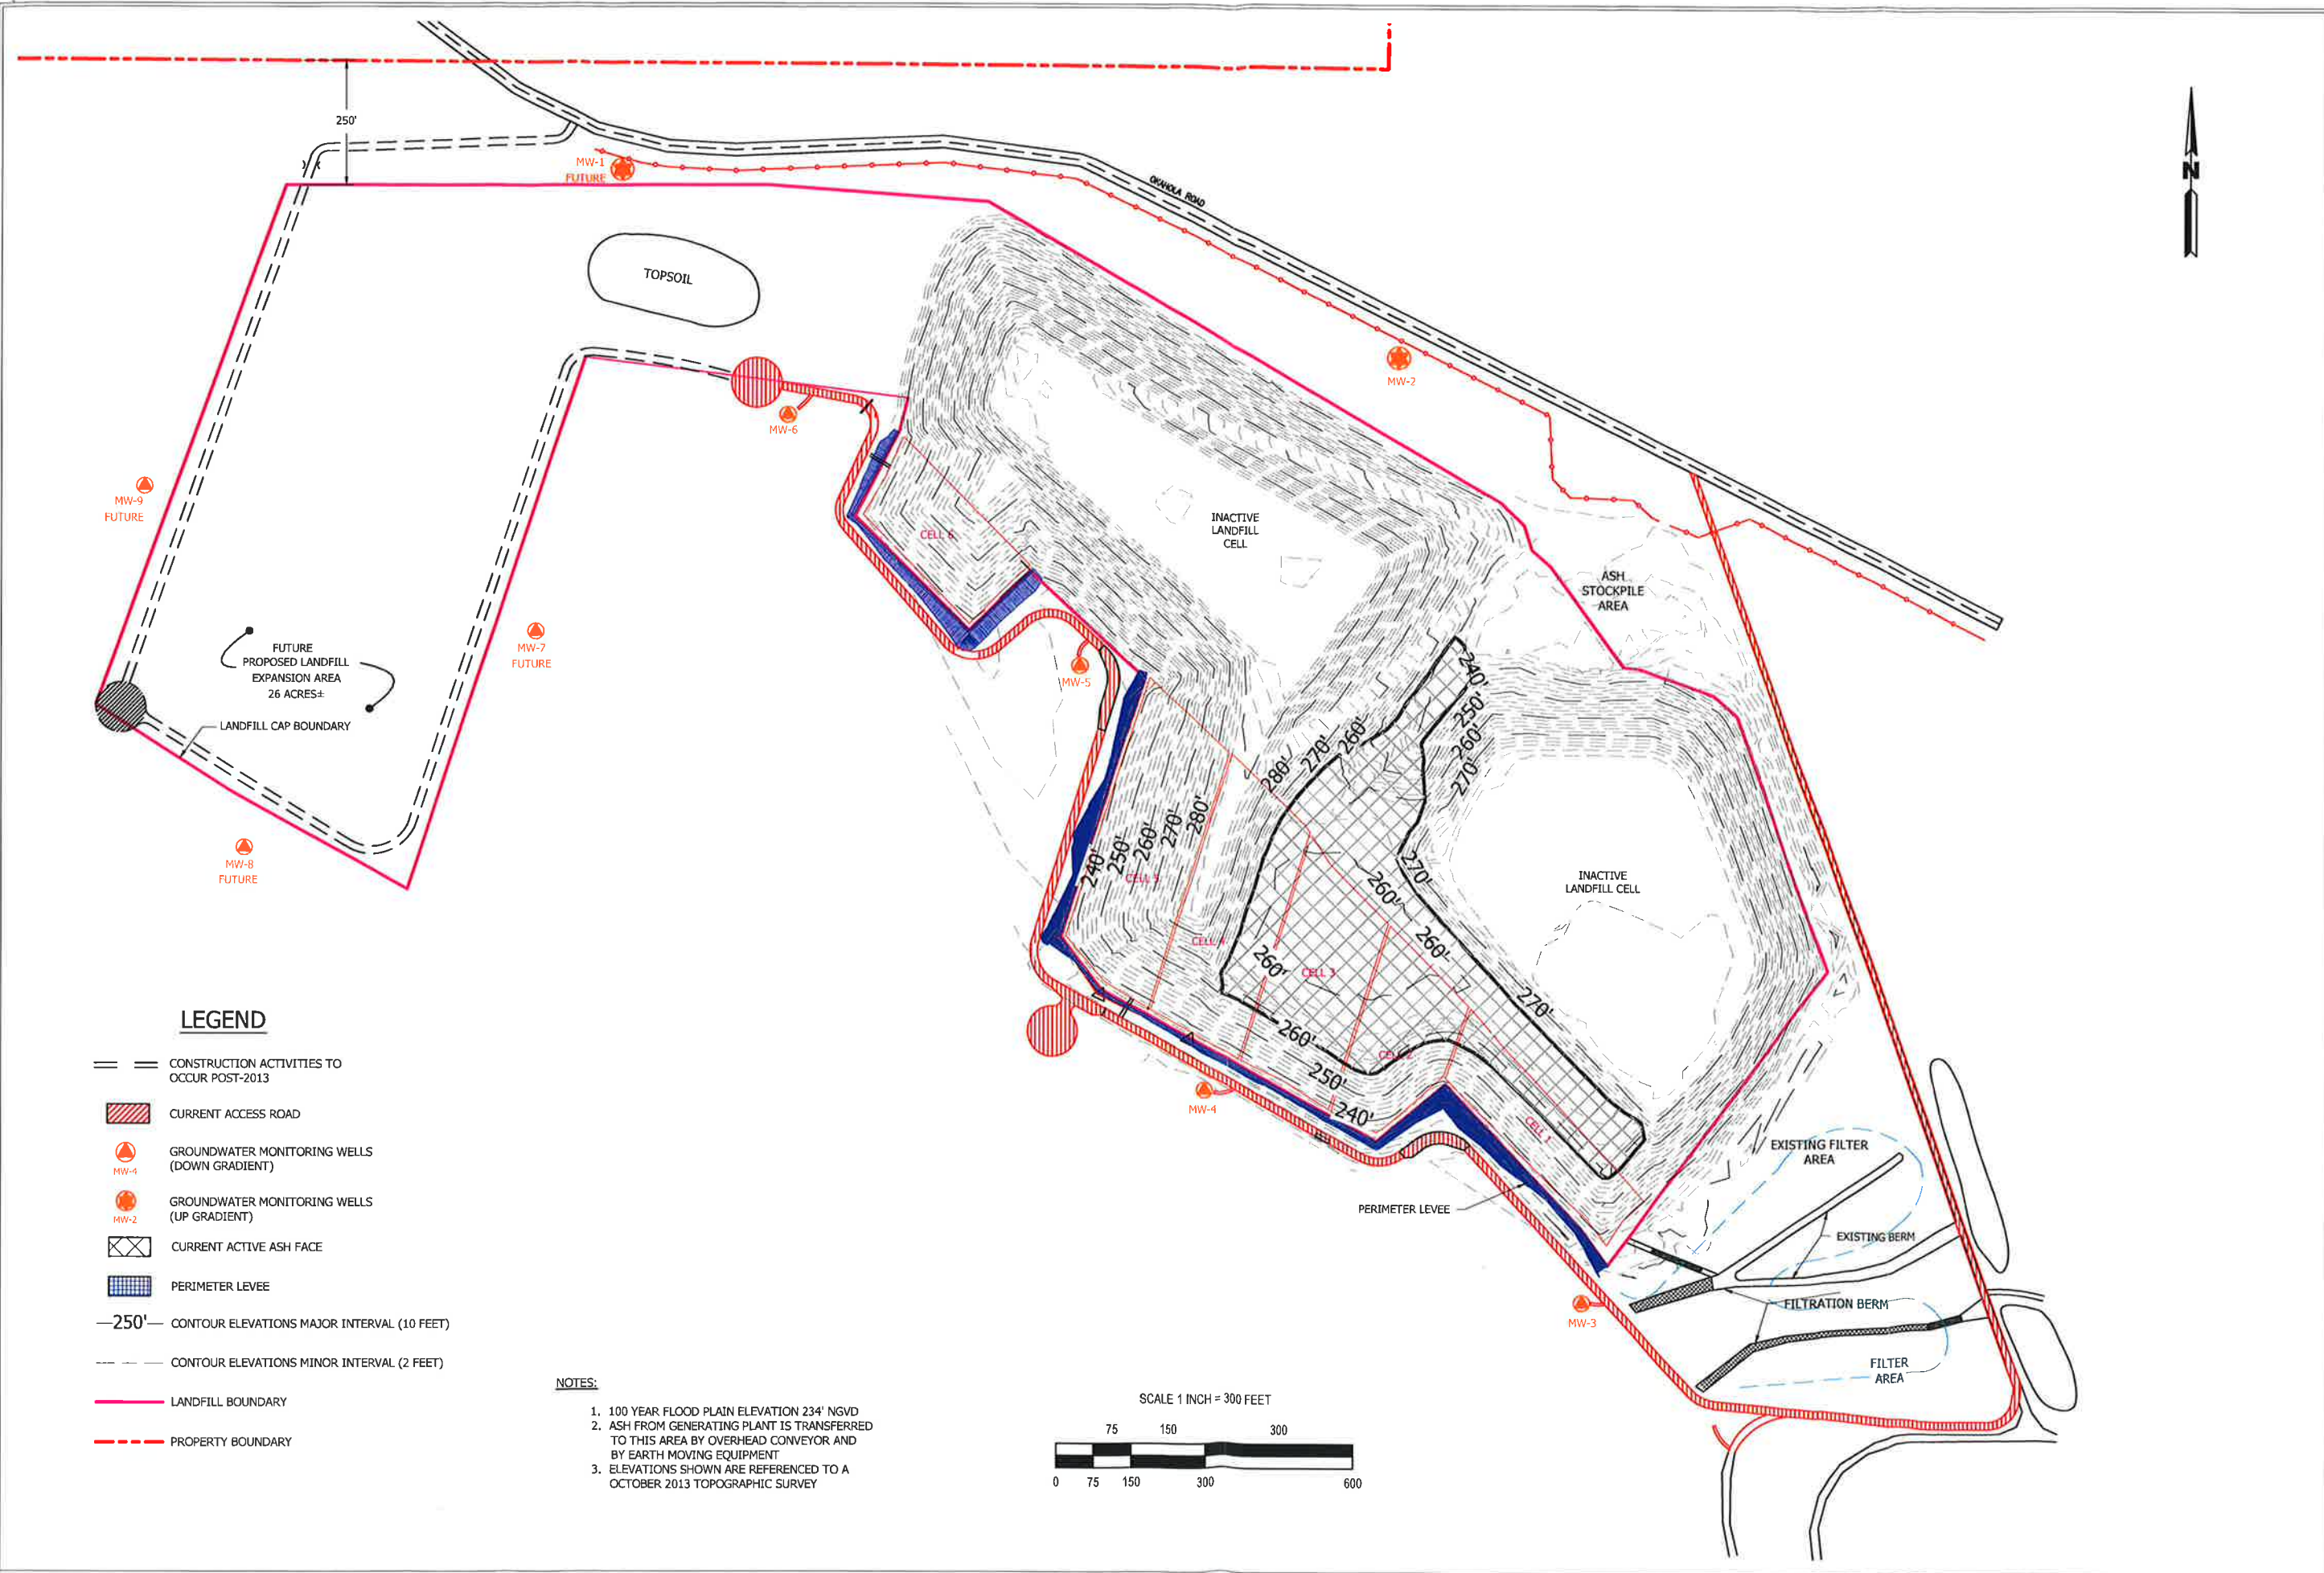
SITE PLAN
R.D. MORROW, SR. GENERATING PLANT
PURVIS, MISSISSIPPI

Existing Site Plan presented as Figure 2. The 72 acre permitted landfill area includes approximately 46 acres of existing landfill permit and a proposed 26 acre expansion area located to the west of the existing landfill. None of the expansion area has been constructed at this time.

The CCR landfill consists of various cells and partially capped areas as shown in **Figure 2**. An aerial photograph showing the landfill area is shown in **Figure 3**. The entire existing operating footprint of the landfill is regulated as an "existing CCR landfill" in accordance with the definitions in the CCR Rule. The proposed expansion will be classified as a new or lateral expansion of the CCR landfill. However, the landfill also operates under a solid waste permit issued by the Mississippi Department of Environmental Quality.

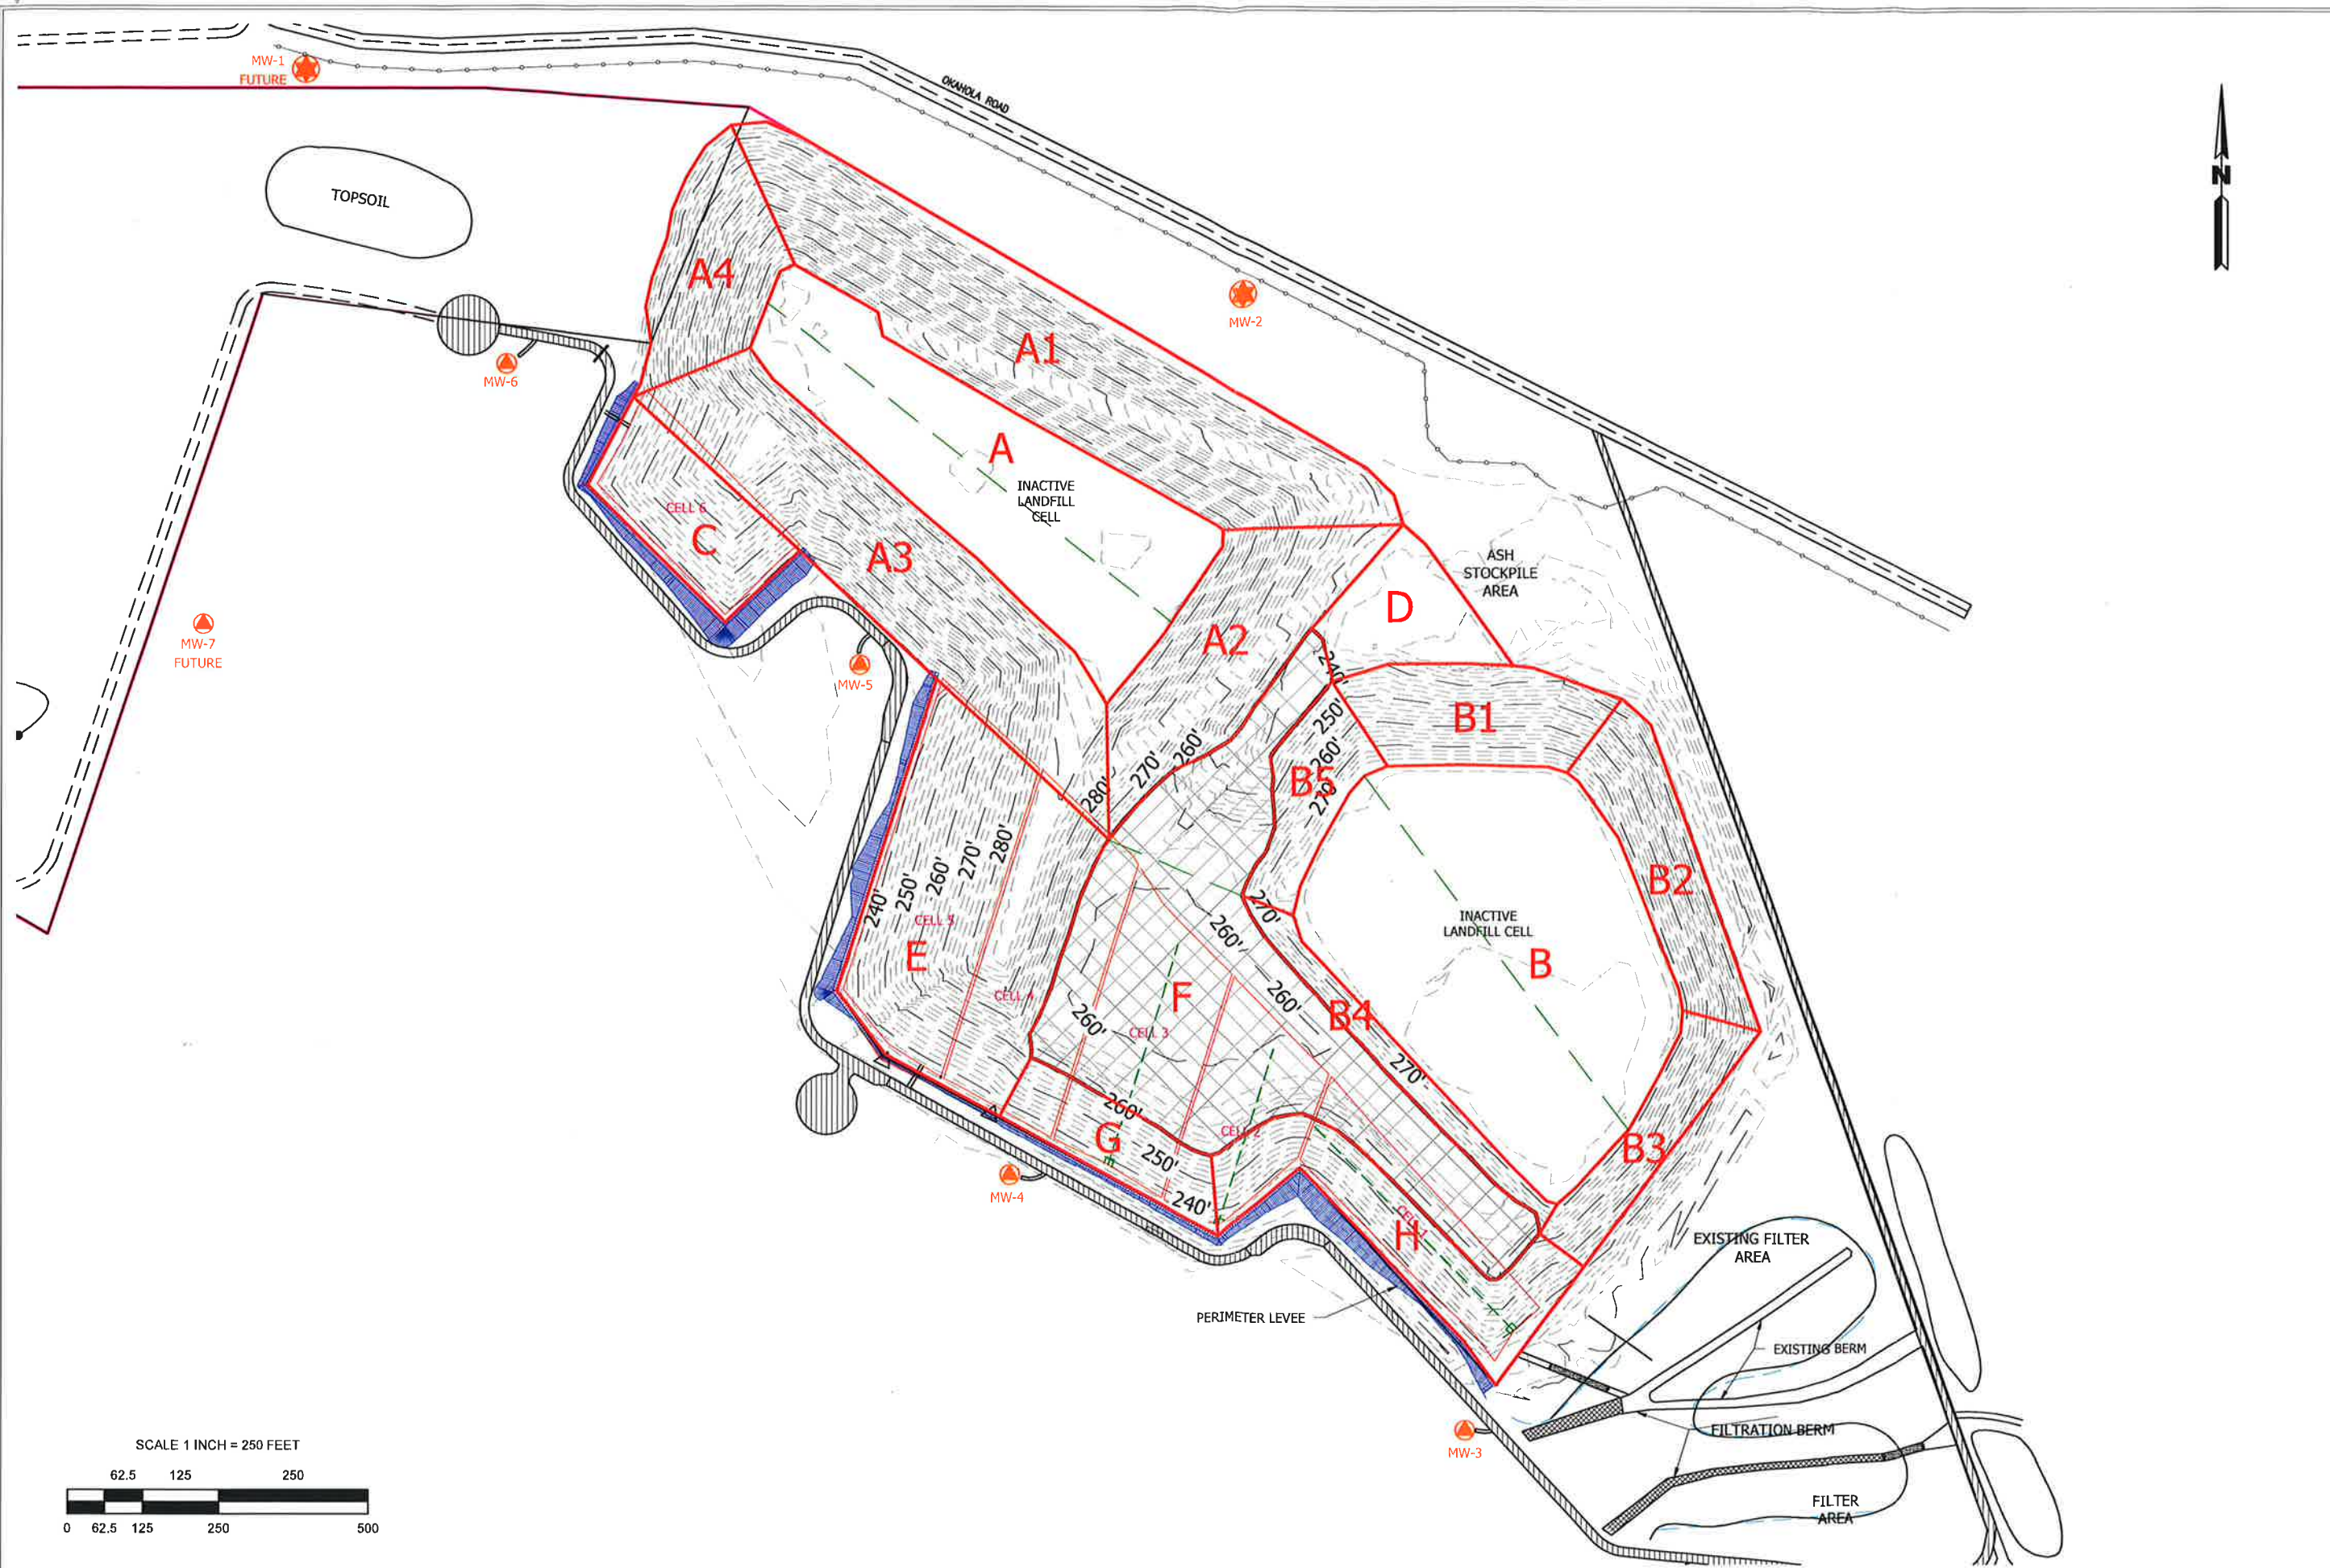
LANDFILL SECTOR INDEX MAP
R.D. MORROW, SR. GENERATING PLANT
PURVIS, MISSISSIPPI

An index map showing the various portions of the active landfill with alphanumeric sector labels is provided in **Attachment A**. At the time of the inspection, CCR materials were being placed in Sector F as shown on the index map.

An unexpected growth of cattails was found in Sector A2 at a portion of its junction with Sector F. Upon visual inspection it was discovered that leachate from Sector A2 was seeping out in the area, and an erosion feature has occurred in the seepage area, perhaps due to the saturated soil conditions (and consequent vegetative stress) and surface drainage flow.

Generally, very little significant erosion was noted on the landfill. Some early stage rill erosion was beginning to form on some of the long slopes in areas such as Sectors A1, C, and E. At this time the rills tend to be less than about 3 to 4 inches deep. These areas should be checked again in the next annual inspection. Corrective measures are not required at this time, but may be needed within the next 12 to 24 months. Ideally any re-grading of topsoil should be scheduled to occur in the spring so that wet weather could facilitate the regrowth of grass before dry and hot summer conditions adversely affect new vegetation growth.

Based on a review of available information and the August 22, 2016 and November 22, 2016 observations, EMS found no significant indications of structural weakness of the landfill. However, saturated conditions, seepage, and small soil creep along a portion of the boundary between Sectors A2 and F were noted.

- Repair the seepage and soil erosion area along the boundary between Sectors A2 and F.

- Clean out ditches along the southern side of landfill to remove cattail vegetation.
- Improve the maintenance of the landfill leachate siphon system to keep the leachate levels pumped down before the level rises to the point that it reaches the gravity overflow.
- Perform re-grading of topsoil on capped areas of the landfill where erosion rills are beginning to form.
