December 26, 2017

Re: Annual CCR Landfill Inspection Report for 2017
R.D. Morrow, Sr. Power Generating Station
Purvis, Lamar County, Mississippi

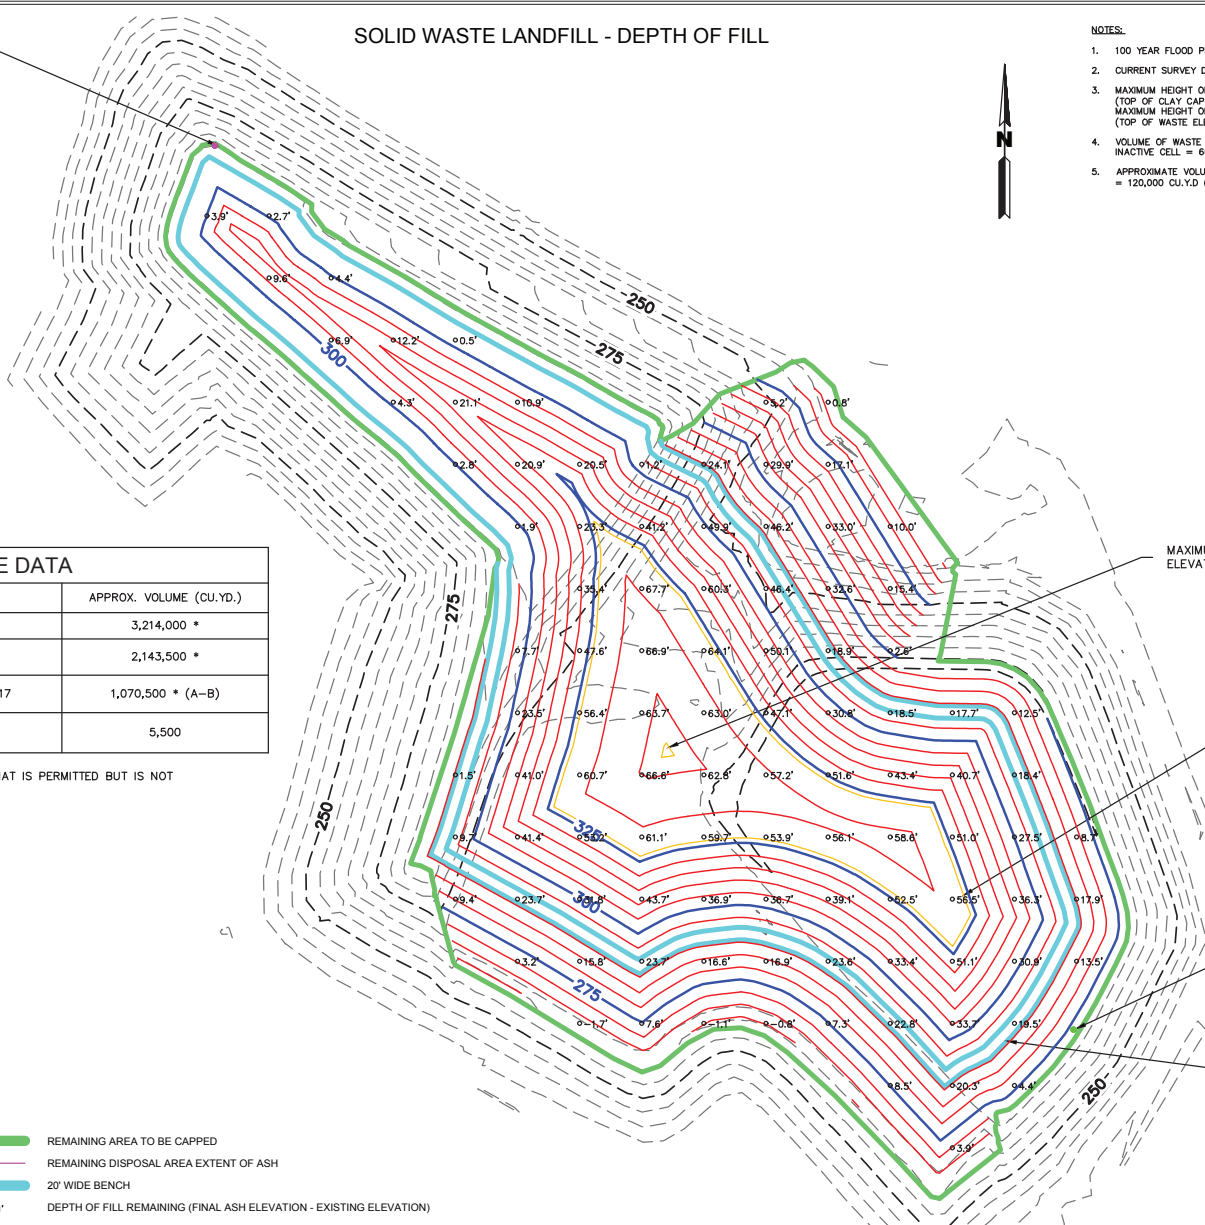
SOLID WASTE LANDFILL - DEPTH OF FILL

As described in the previous section, an AutoCAD® surface model was prepared based on an elevation survey of the landfill. The model surface was compared to the prior year model surface using the AutoCAD® Civil 3D package to calculate the change in volume from 2016 to 2017. The map representing the results of this effort is included as **Figure 5** Depth of Fill Map showing airspace volume calculations.

The CCR volume in the Landfill as of October 3, 2017, is estimated to be approximately 2,143,500 cubic yards (CY). Approximately 5,500 CY of material was added to the landfill since the last survey conducted November 22, 2016. Based on the design volume and the latest topographic survey, approximately 1,070,500 CY of airspace remains available in the developed portion of the landfill.
