December 21, 2018

Re: Annual CCR Landfill Inspection Report for 2018 Revision 1
R.D. Morrow, Sr. Power Generating Station
Purvis, Lamar County, Mississippi

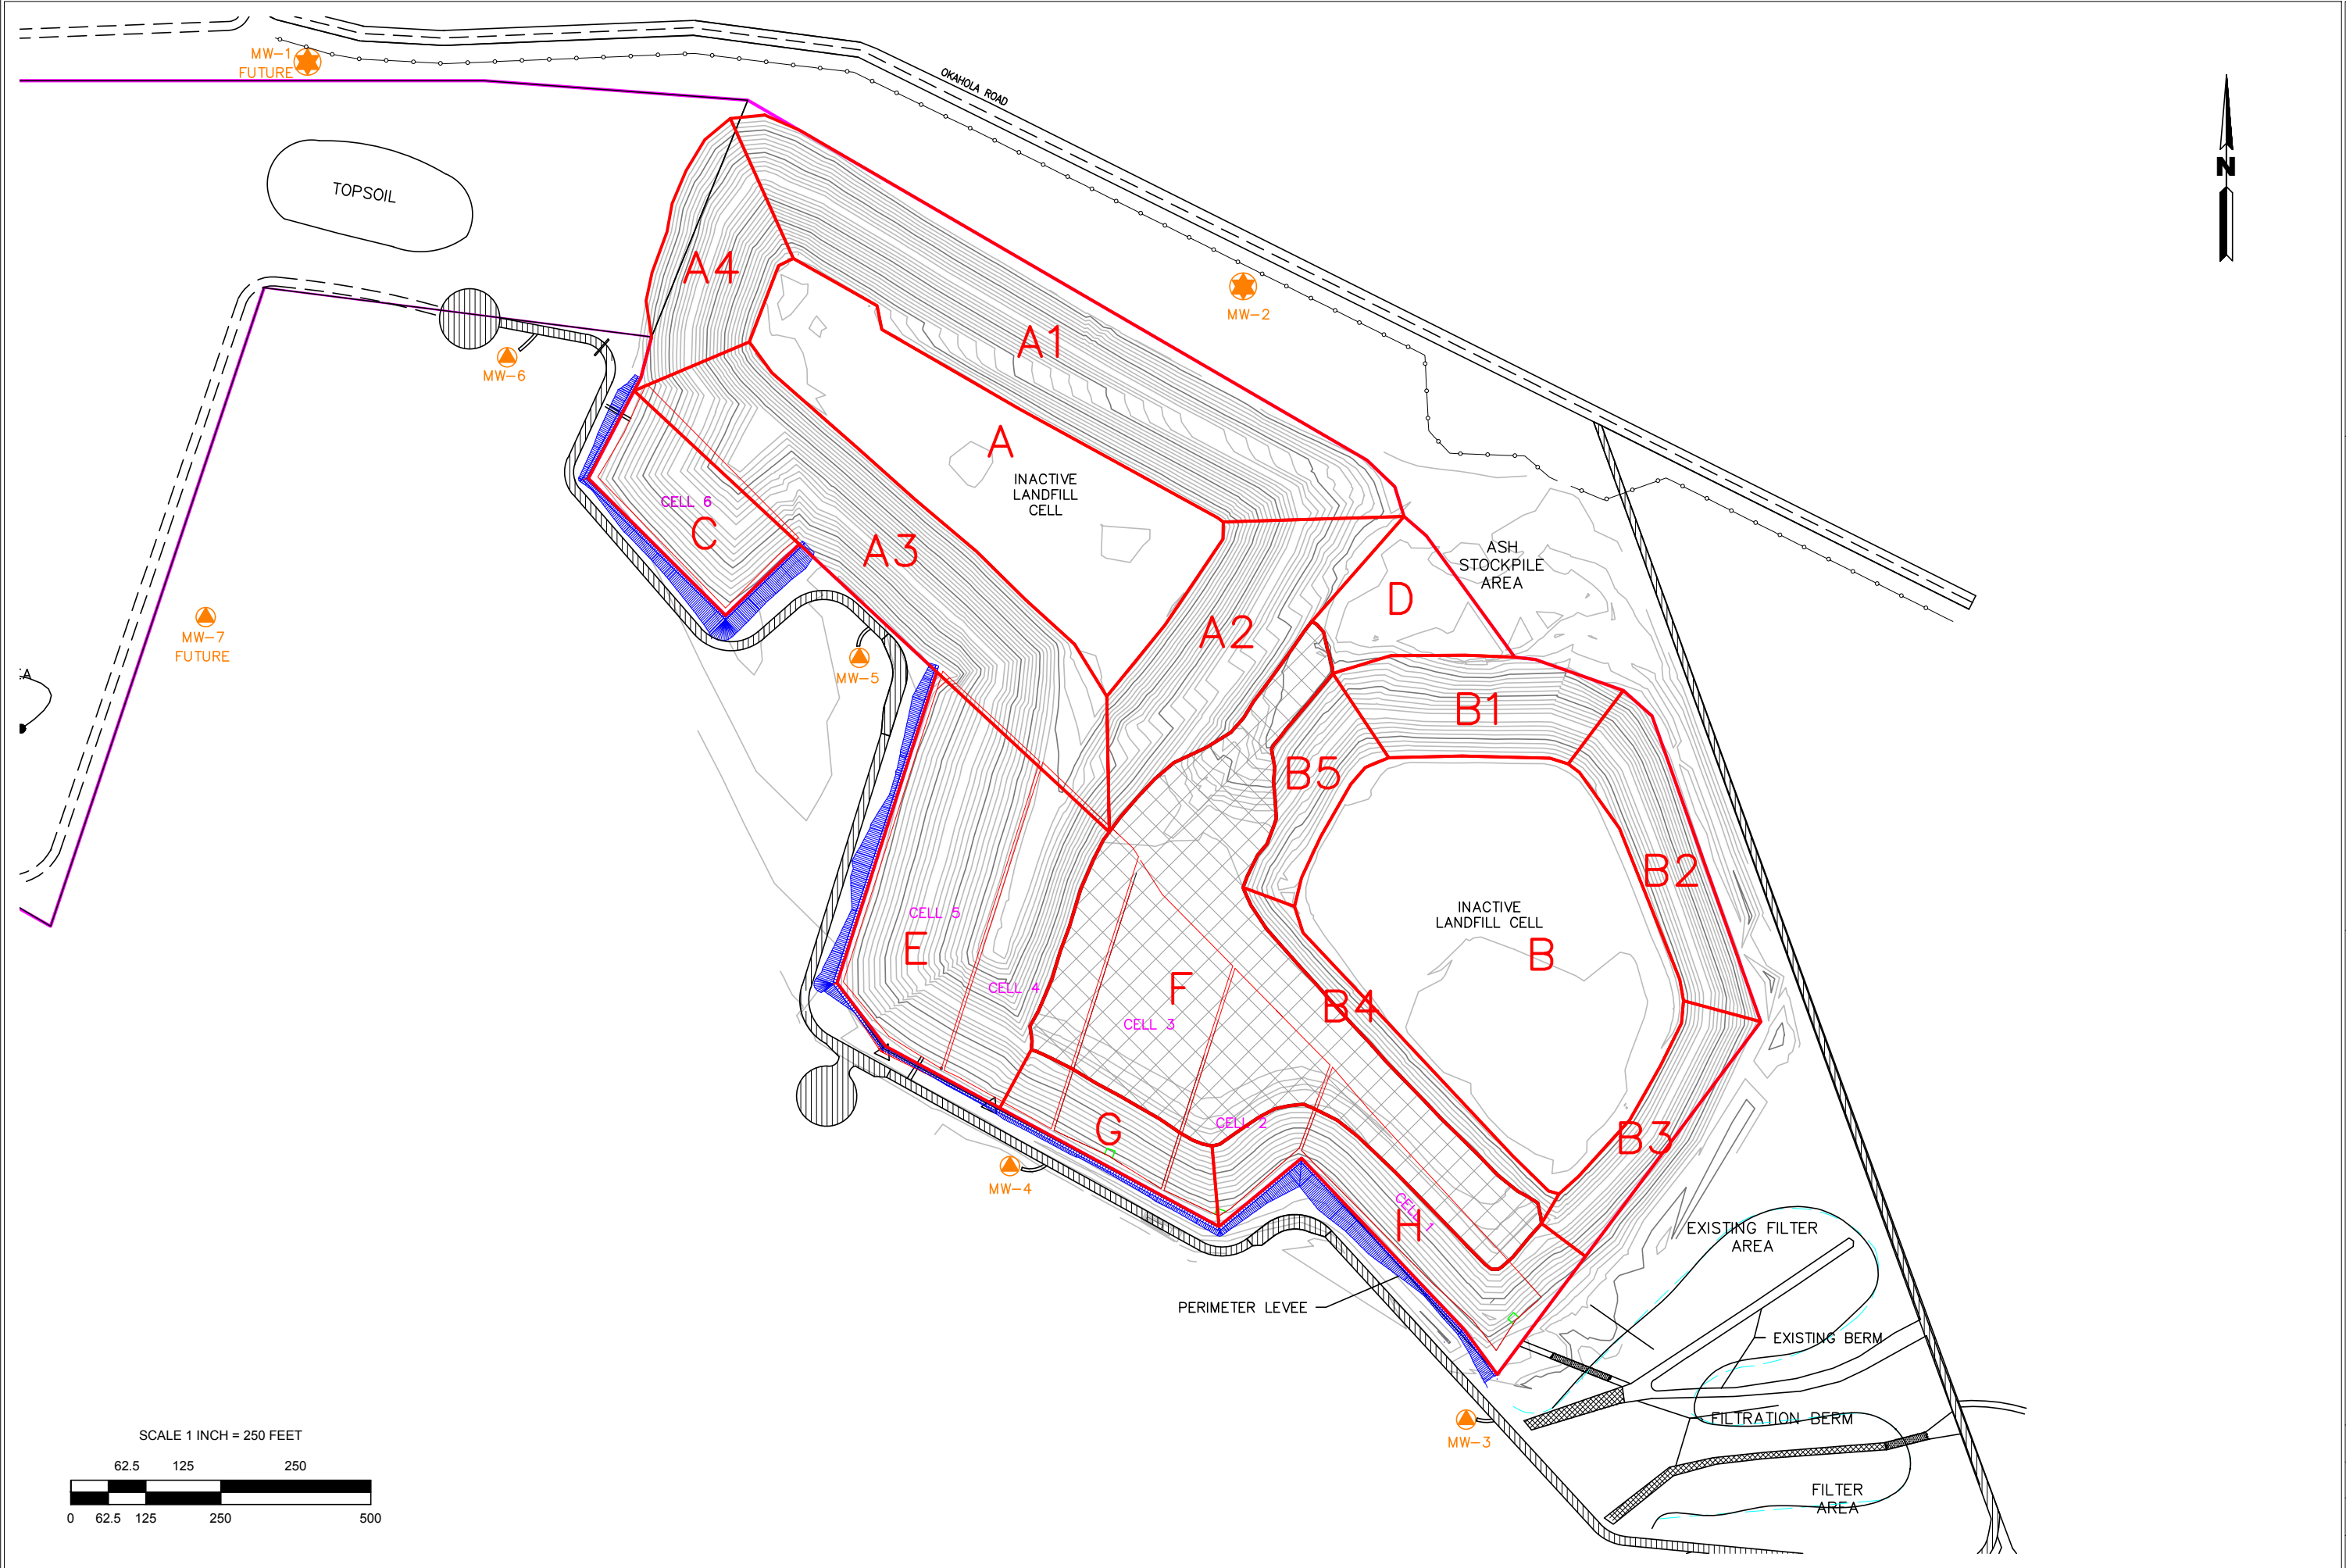
SHEET NO. 4

A landfill sector index map showing the various portions of the active landfill with alphanumeric sector labels is attached as **Figure 4**. At the time of the inspection, CCR materials had recently been placed in Sector F as shown on the index map. In preparation to repower the plant, remaining unburned coal from the coal pile is being placed into Sector F, as approved by the MDEQ.

The eastern edge of Sector A2 which had seepage during the 2017 inspection contained very little seepage during the 2018 inspection, and conditions are better than 2017. A small seep was identified at the

western toe of Sector A4. Active seeps with associated erosion were identified on the northern boundary of Sector A1. This condition and planned corrective measures are described further in Section 8.0 below.

Erosion was noted in December 2018 within seepage areas along the northern boundary of Sector A1. Early stage rill erosion that was beginning to form during the 2016 annual inspection could not be located during the 2017 and 2018 inspections. Increased grass growth and routine maintenance and mowing appears to have mitigated the prior erosion rills. Therefore, no corrective measures are required for this area. The seeps and erosion on the northern boundary of Sector A1 are addressed in Section 8.0 below.

Based on a review of available information and the December 7, 2018 observations, EMS found no significant indications of structural weakness of the landfill. Seepage and erosion along Sector A1 northern boundary was identified, but this area has gravel-filled toe drains that were installed over 10 years ago to relieve hydrostatic pressure in that area. In addition saturated conditions, seepage, and bare soil were observed along a portion of the boundary between Sectors A2 and F. A small saturated area was identified on the western edge of Sector A4.

While seepage conditions have been identified in and around Sector A, these conditions are not expected to disrupt the operation and safety of the CCR landfill given that they have been in steady state conditions for many years. We recommend that Cooperative Energy continue to perform weekly inspections of the landfill to monitor for any conditions that would indicate a change or worsening of the seepage conditions.

As described in Section 7.0, it is anticipated that as part of the repower project Cooperative Energy will initiate closure of the CCR Landfill. We recommend that improvements be constructed during the closure process that will mitigate the seepage conditions.

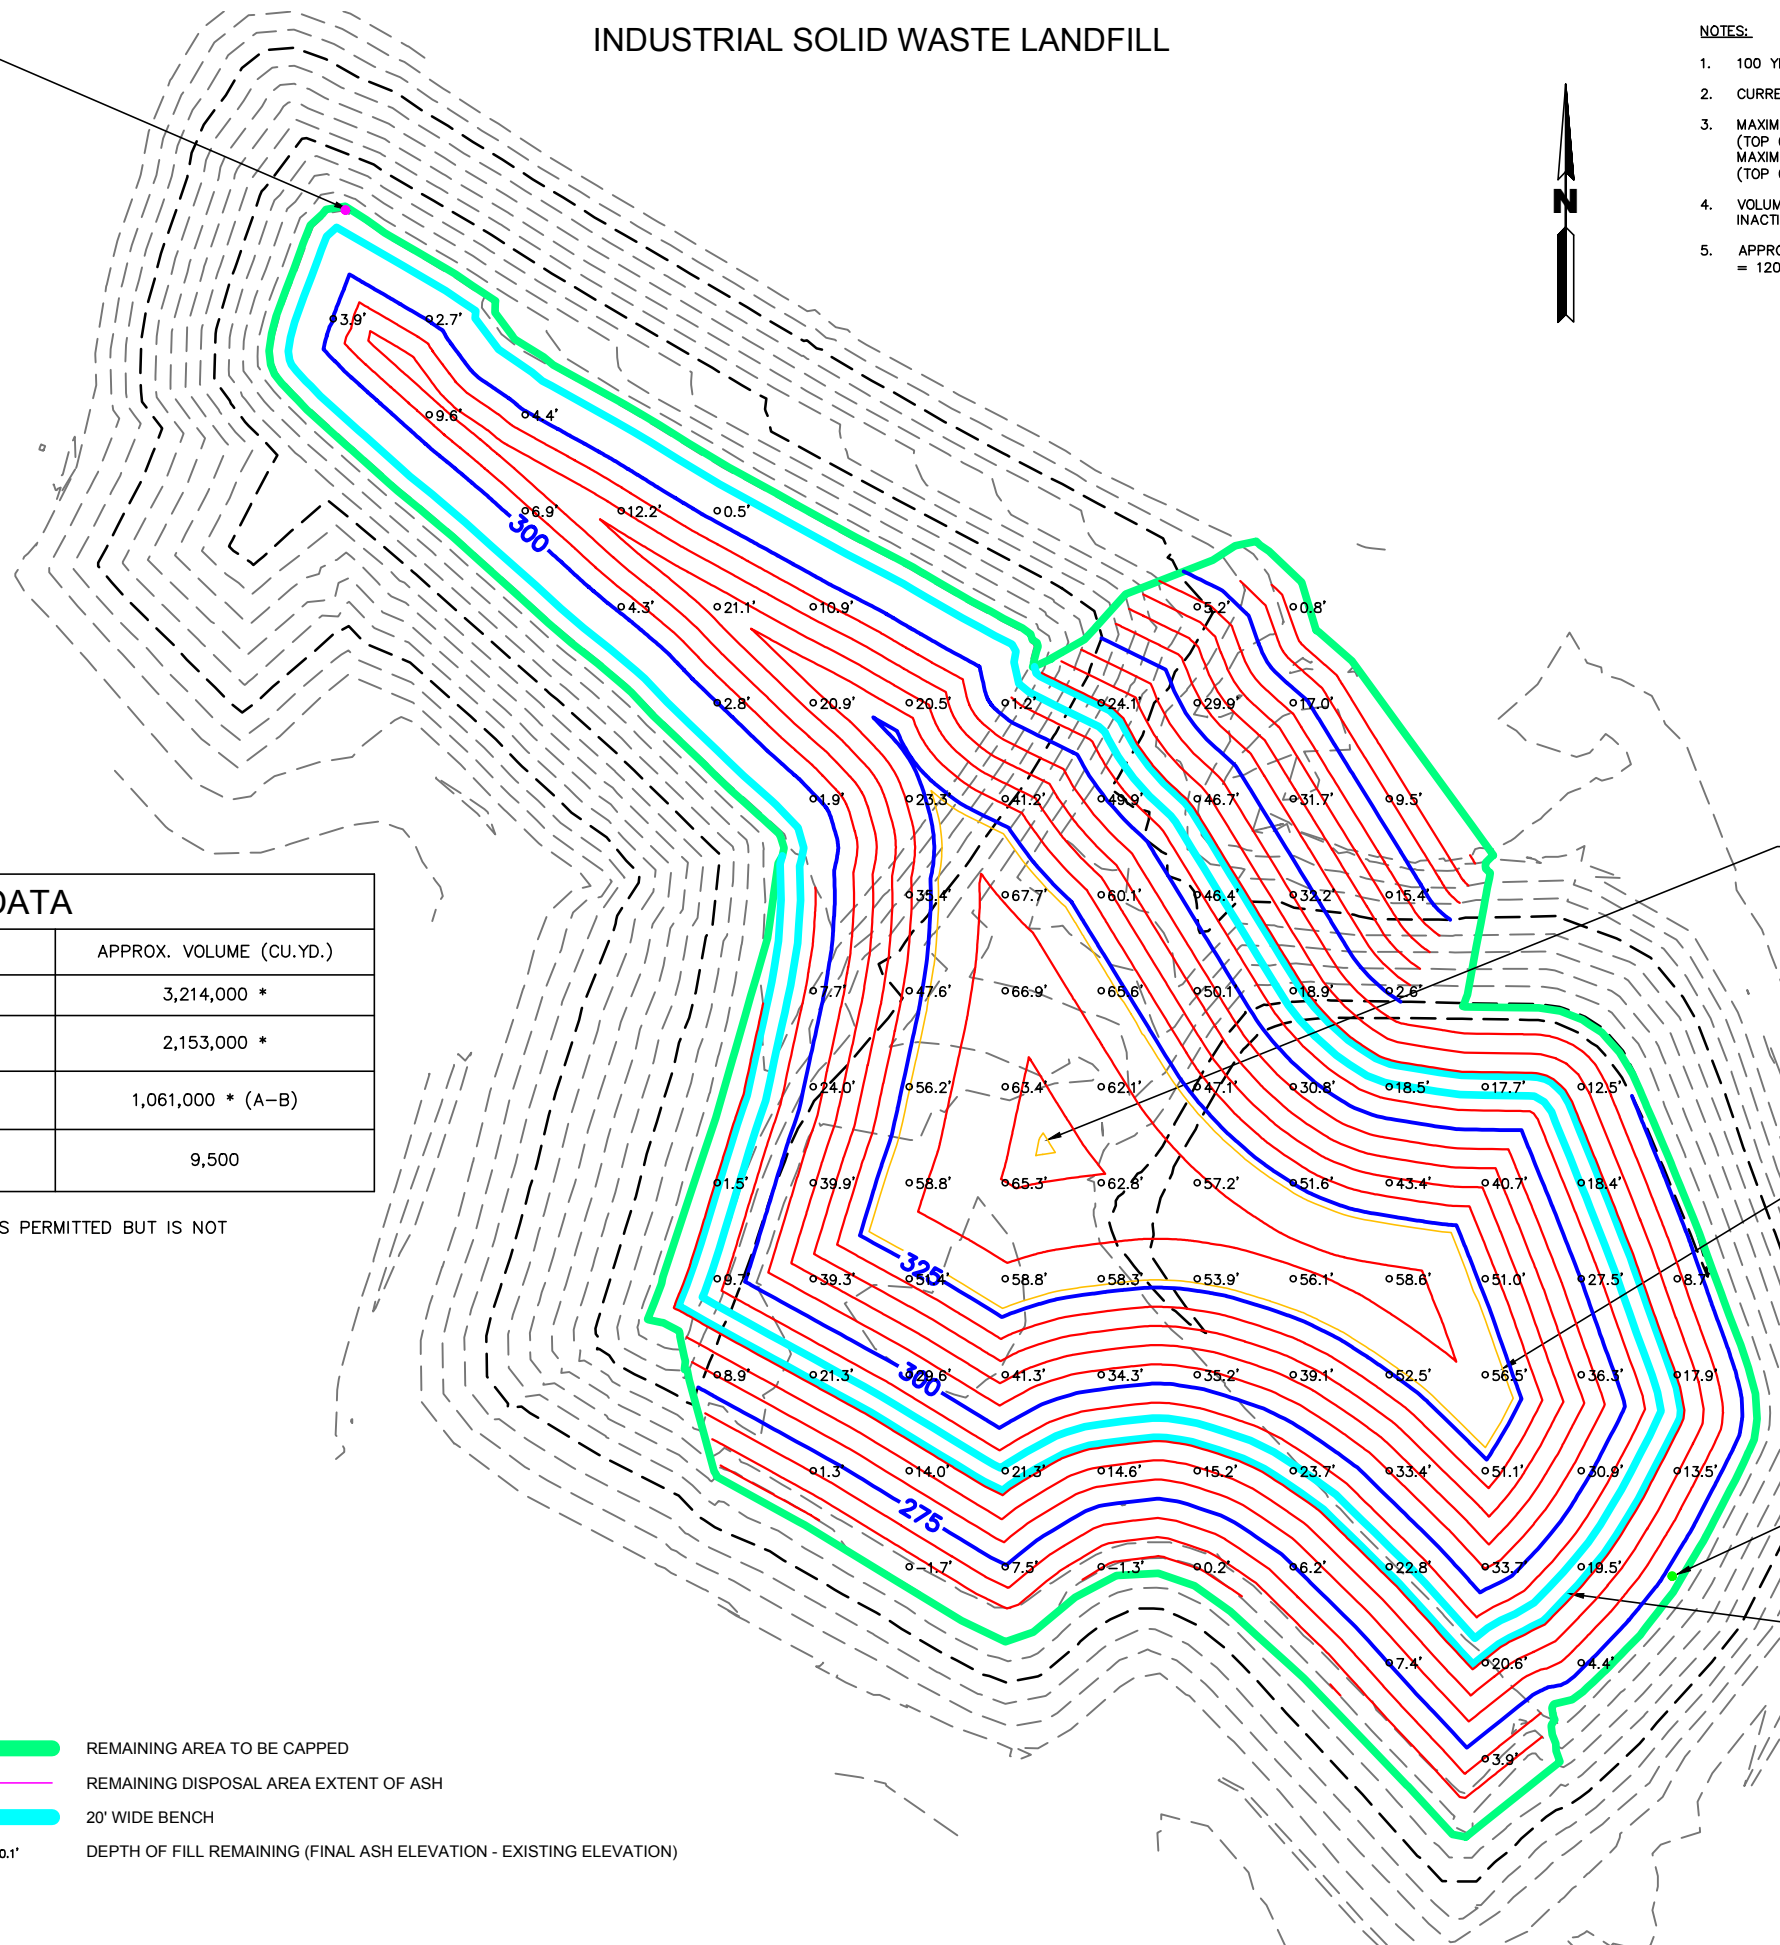
As described in the previous section, an AutoCAD® surface model was prepared based on an elevation survey of the landfill. The model surface was compared to the prior year model surface using the AutoCAD® Civil 3D package to calculate the change in volume from 2017 to 2018. The map representing the results of this effort is included as **Figure 5 – 2018 Airspace Calculations** showing airspace volume calculations.

The CCR volume in the Landfill as of September 11, 2018, is estimated to be approximately 2,153,000 cubic yards (CY). Approximately 9,500 CY of material was added to the landfill since the last survey conducted October 3, 2017. Based on the design volume and the latest topographic survey, approximately 1,061,000 CY of permitted airspace remains available in the developed portion of the landfill.
