December 20, 2019

Re: Annual CCR Landfill Inspection Report for 2019
R.D. Morrow, Sr. Power Generating Station
Purvis, Lamar County, Mississippi

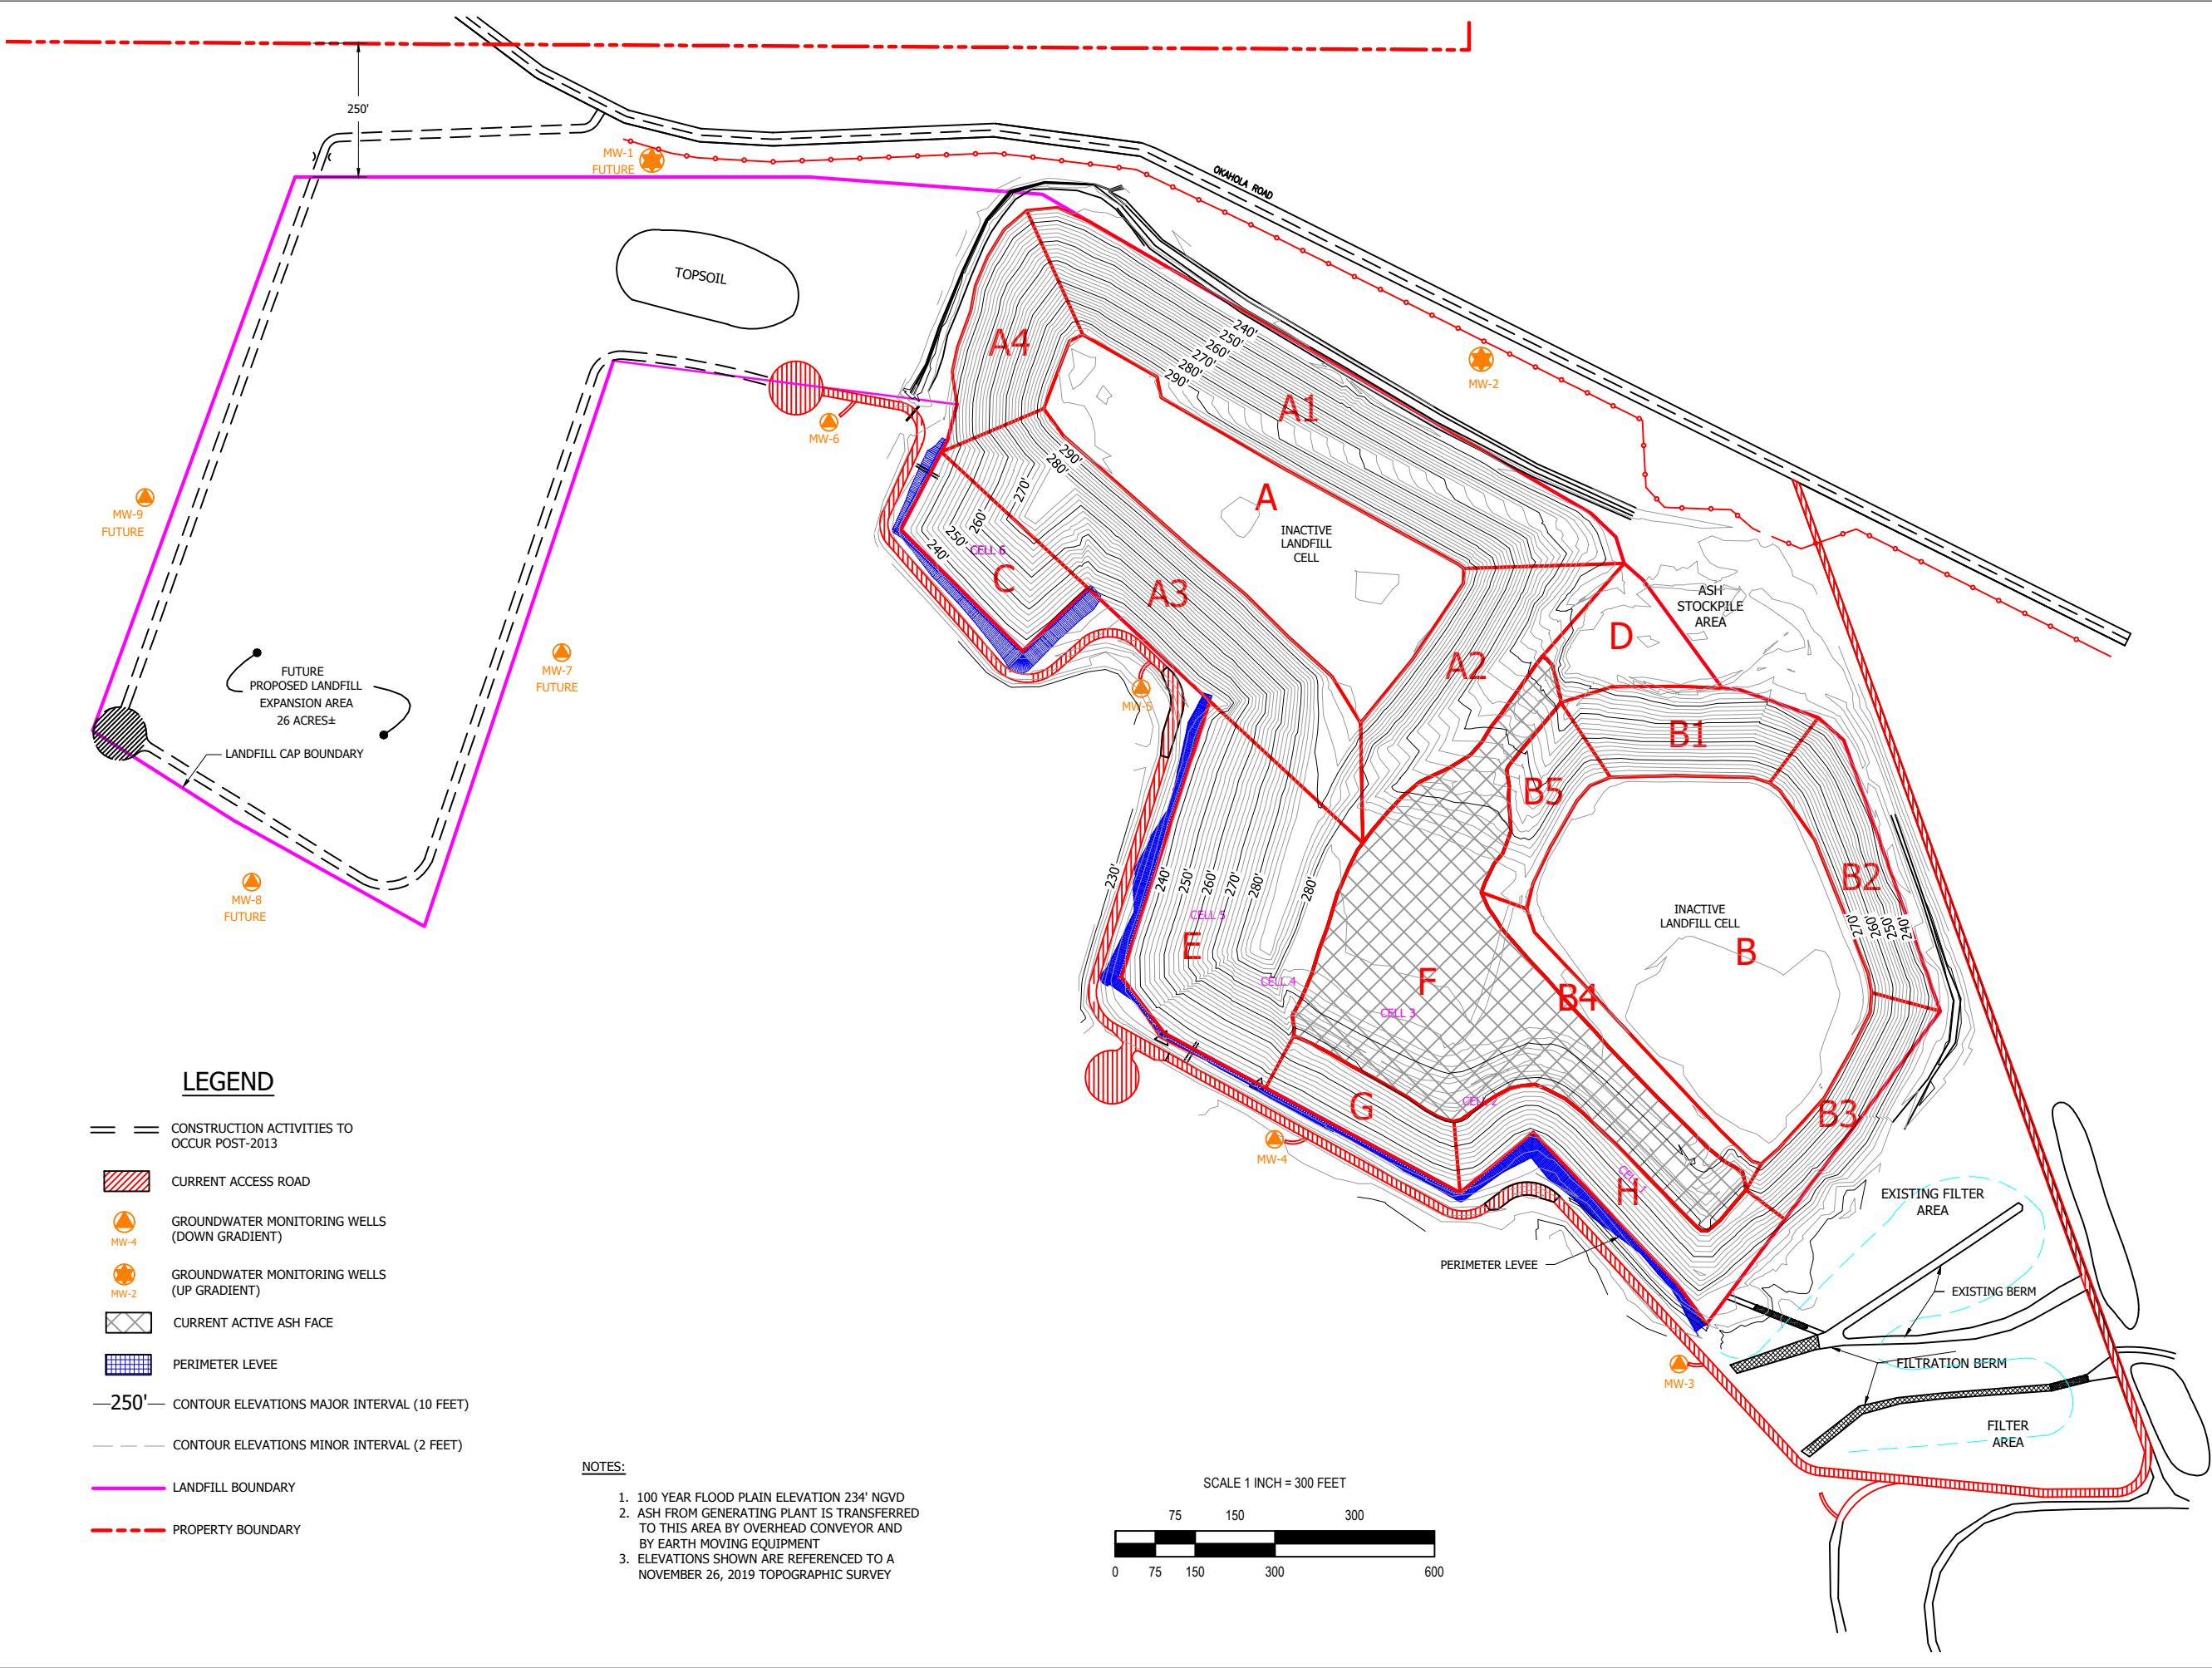
LANDFILL SECTOR INDEX MAP
R.D. MORROW, SR. GENERATING PLANT
PURVIS, MISSISSIPPI

A landfill sector index map showing the various portions of the active landfill with alphanumeric sector labels is attached as **Figure 4**. At the time of the inspection, unburned coal had recently been placed in Sector F as shown on the index map. In preparation to repower the plant, remaining unburned coal and coal residuals from the coal pile and runoff pond are being placed into Sector F, as approved by the MDEQ.

The eastern edge of Sector A2 which had seepage during the 2018 inspection contained very little seepage during the 2019 inspection, and conditions are better than 2018. A small seep was identified at the western toe of Sector A4. Active seeps with associated erosion were identified on the northern boundary of Sector A1. This condition and planned corrective measures are described further in Section 8.0 below.

Some erosion was noted in November 2019 within seepage areas along the northern boundary of Sector A1. The seeps and erosion on the northern boundary of Sector A1 are addressed in Section 8.0 below. A seep on the eastern edge of Sector A2 that has been noted in previous inspections has led to some sloughing of the interim slope adjacent to the active haul road through Sector D. This area exhibits steady conditions since the last annual inspection and no corrective measures are recommended at this time. Filling at Sector F has resulted in an increase in storm water runoff flow at the southwest corner of the Sector. Although wire-backed silt fence is in place along the perimeter of the new fill in the sector, the flow of storm water had resulted in coal/coal residual transport down a portion of the face of Sector G to the perimeter ditch during times of heavy rainfall. Work to remove these materials from the ditch and slope face have been performed after these events. Measures to prevent the erosion of these materials are being developed at this time.

Based on a review of available information and the November 26, 2019 observations, EMS found no significant indications of structural weakness of the landfill. Seepage and erosion along Sector A1 northern boundary was identified, but this area has gravel-filled toe drains that were installed over 10 years ago to relieve hydrostatic pressure in that area. In addition saturated conditions, seepage, and bare soil were observed along a portion of the boundary between Sectors A2 and F. A small saturated area was identified on the western edge of Sector A4.

As described in Section 7.0, it is anticipated that as part of the repower project Cooperative Energy will initiate closure of the CCR Landfill. We recommend that improvements be constructed during the closure process that will mitigate the seepage conditions.
