December 26, 2017

Re: Annual CCR Landfill Inspection Report for 2017  
R.D. Morrow, Sr. Power Generating Station  
Purvis, Lamar County, Mississippi

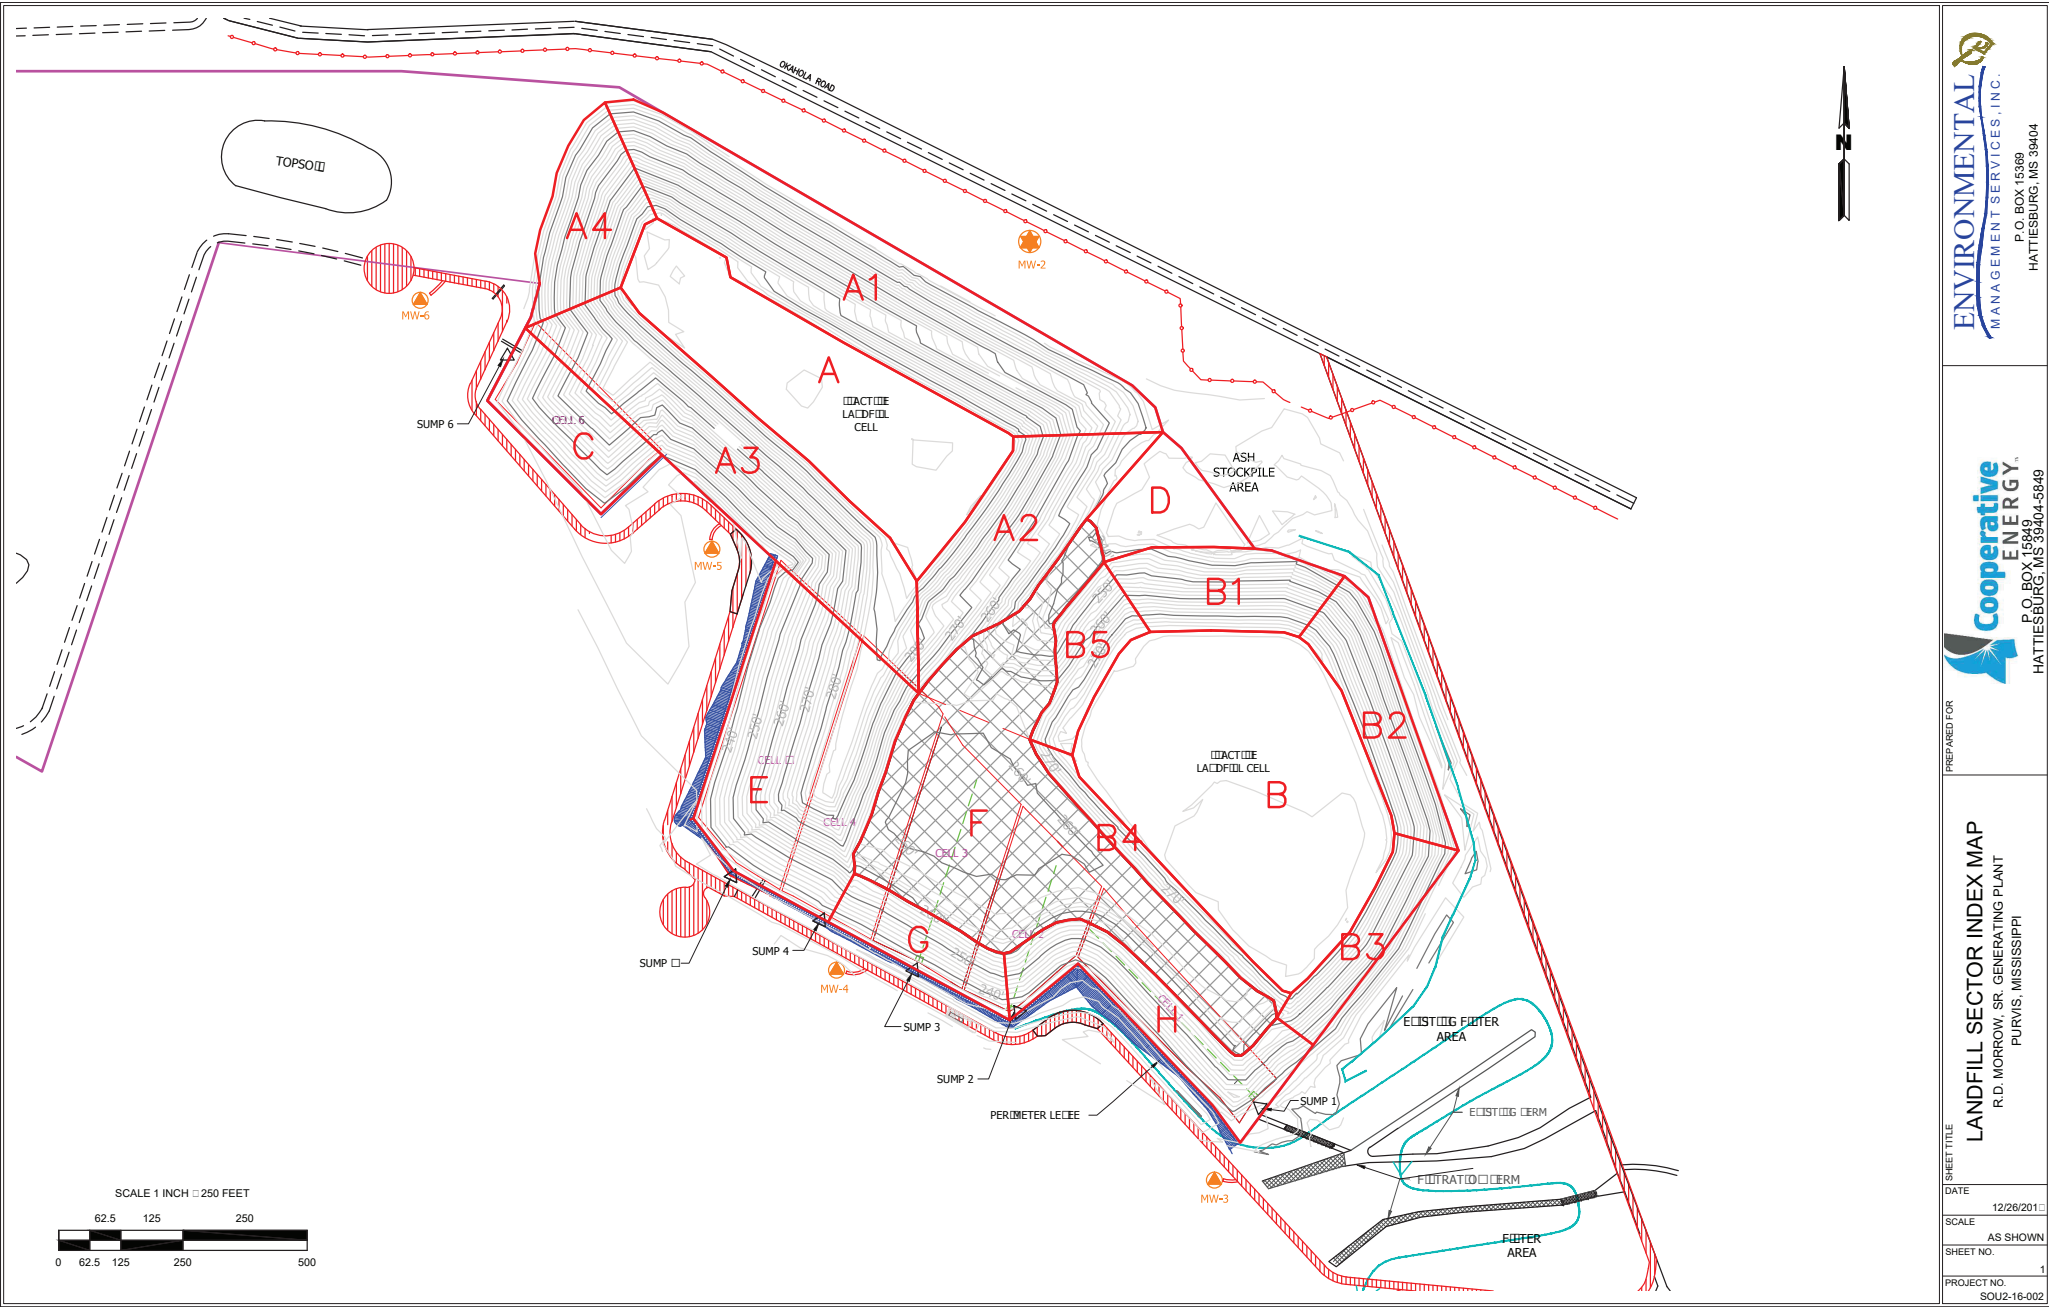
**LANDFILL SECTOR INDEX MAP**  
R.D. MORROW, SR. GENERATING PLANT  
PURVIS, MISSISSIPPI

A landfill sector index map showing the various portions of the active landfill with alphanumeric sector labels is attached **Figure 4**. At the time of the inspection, CCR materials had recently been placed in Sector F as shown on the index map.
