Re: Annual CCR Landfill Inspection Report for 2016  
R.D. Morrow, Sr. Power Generating Station  
Purvis, Lamar County, Mississippi

Cooperative Energy (formerly South Mississippi Electric Power Association) retained Environmental Management Services, Inc. (EMS) to conduct the annual inspection for the coal combustion residuals (CCR) landfill at the R.D. Morrow, Sr. Generating Station in Purvis, Mississippi. The purpose of this report is to comply with the air criteria in the federal Coal Combustion Residual Rule (CCR Rule) 40 CFR 257.84(b)(1) and (b)(2) requiring an annual inspection of the CCR landfill at the subject property.

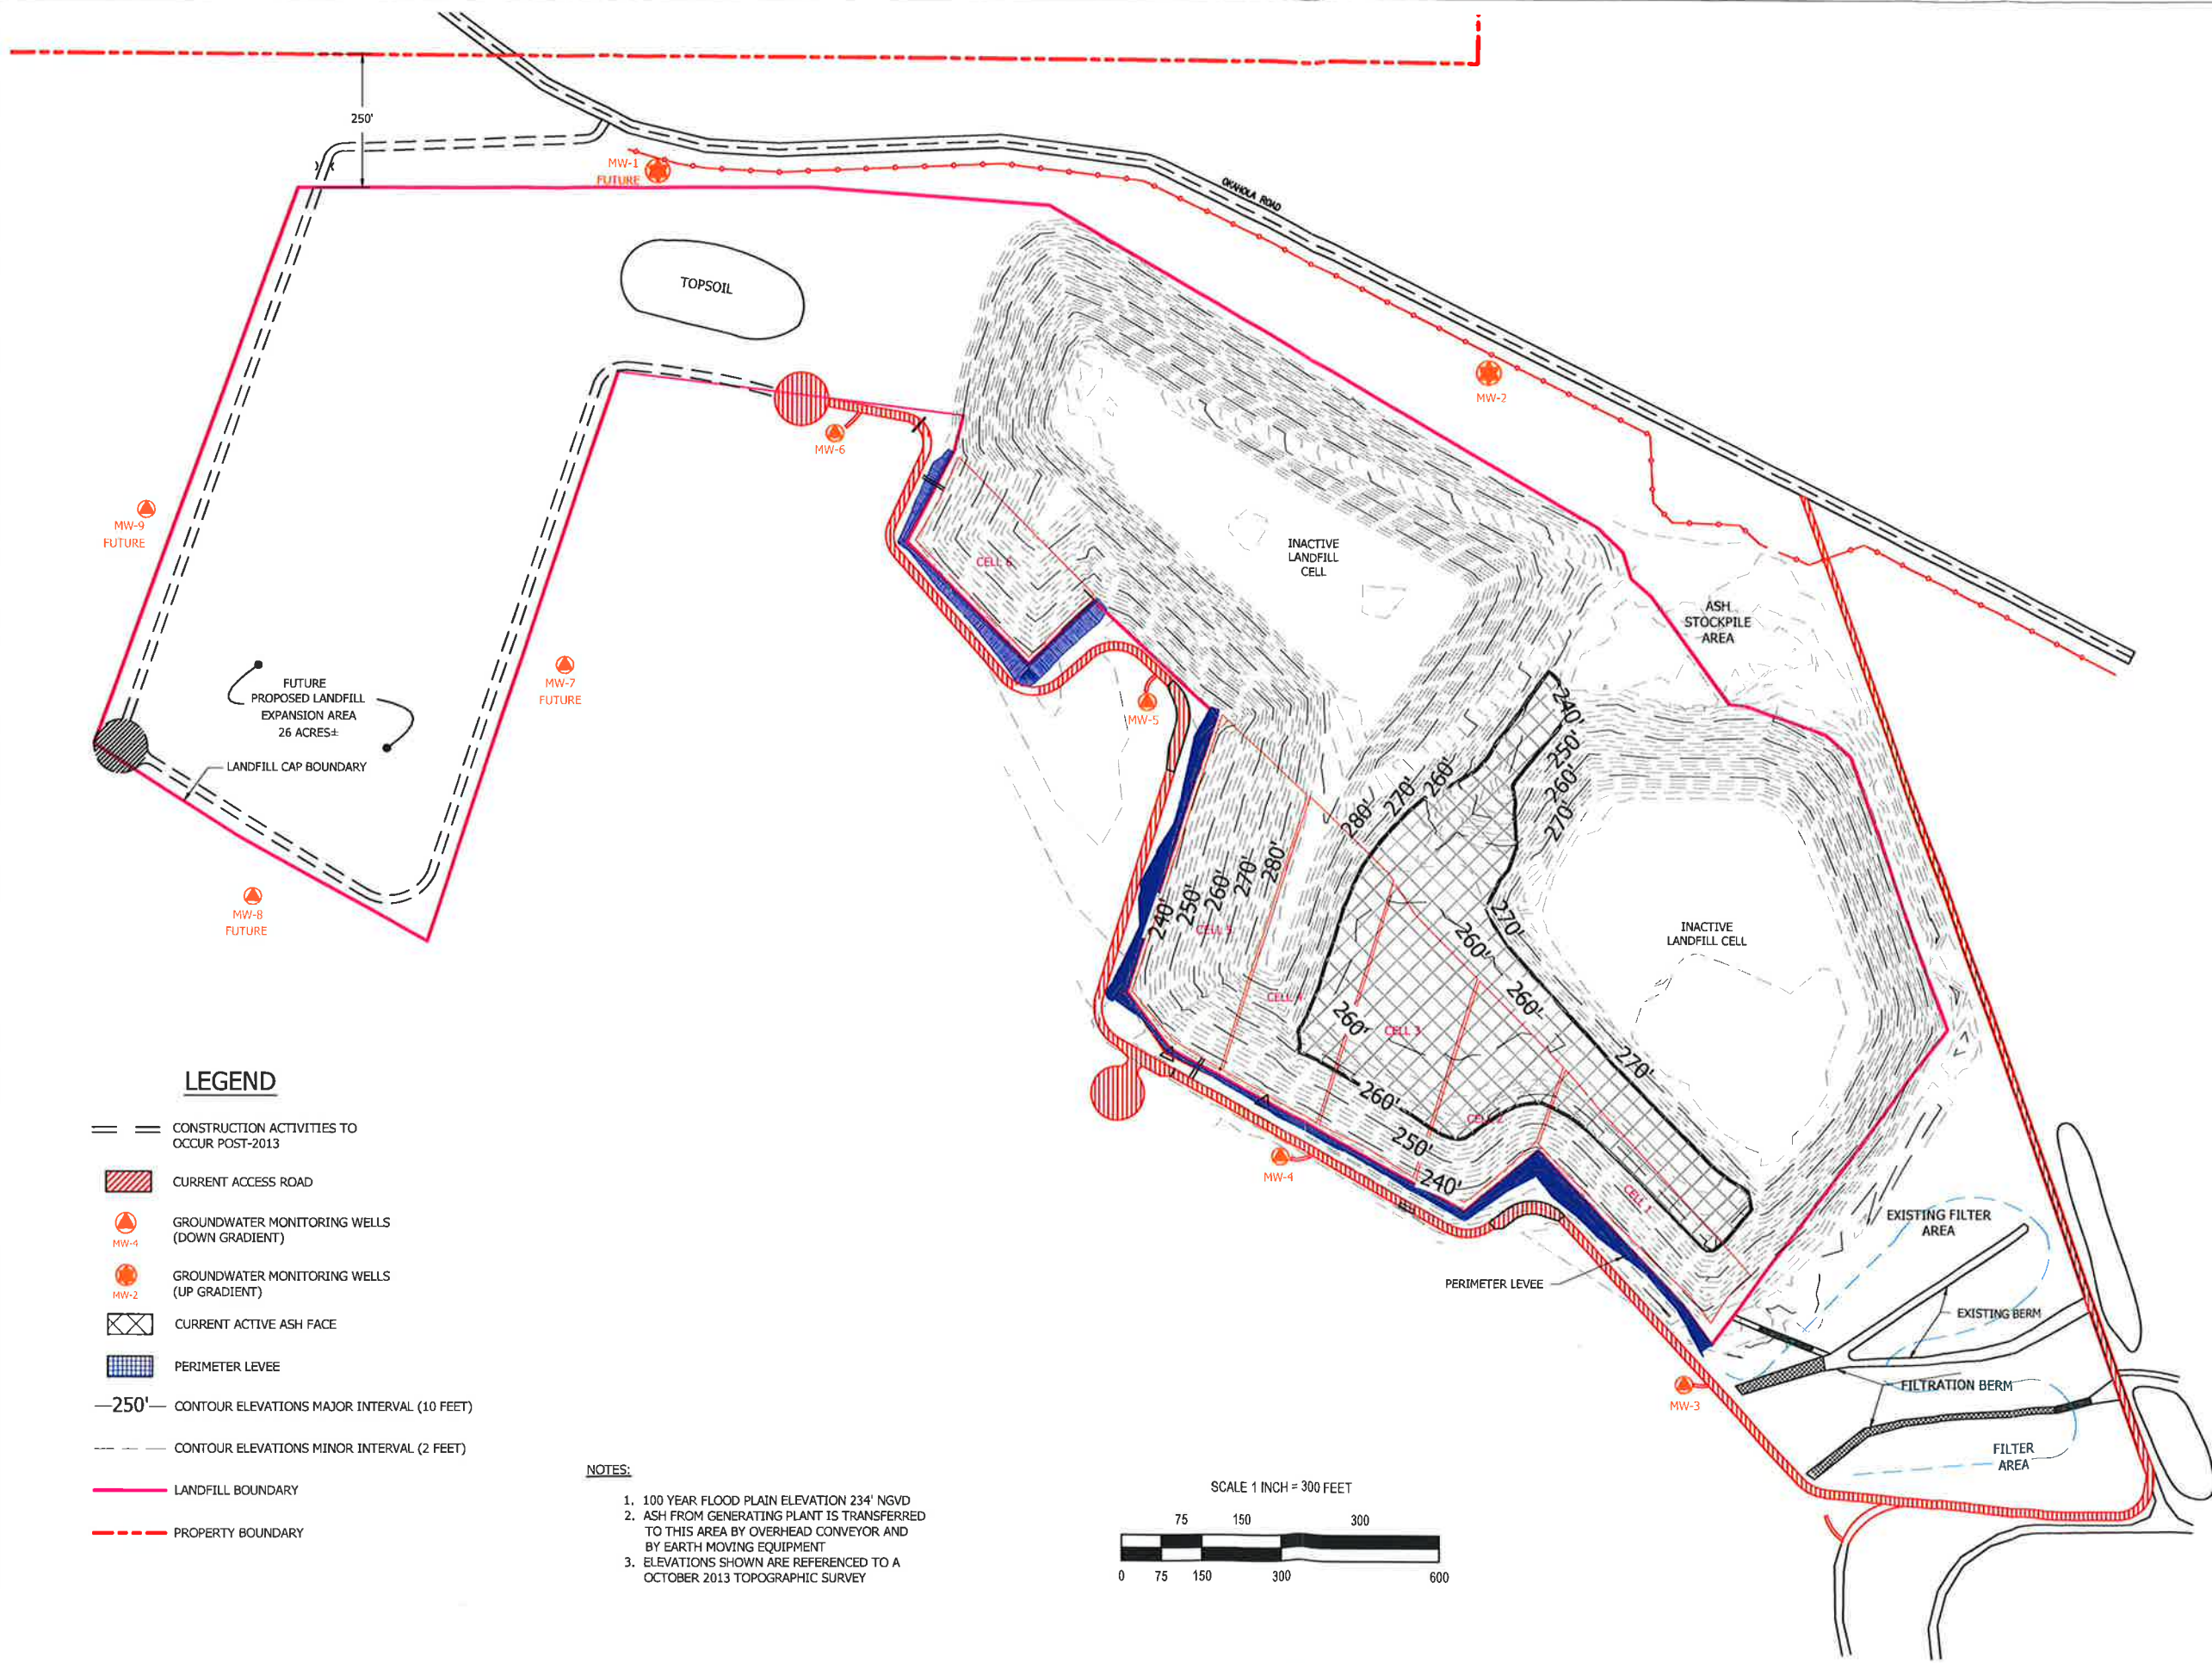
- 100 YEAR FLOOD PLAIN ELEVATION 234' NGVD
- ASH FROM GENERATING PLANT IS TRANSFERRED TO THIS AREA BY OVERHEAD CONVEYOR AND BY EARTH MOVING EQUIPMENT
- ELEVATIONS SHOWN ARE REFERENCED TO A OCTOBER 2013 TOPOGRAPHIC SURVEY
