Re: Annual CCR Landfill Inspection Report for 2020
R.D. Morrow, Sr. Power Generating Station
Purvis, Lamar County, Mississippi

1.0 Introduction

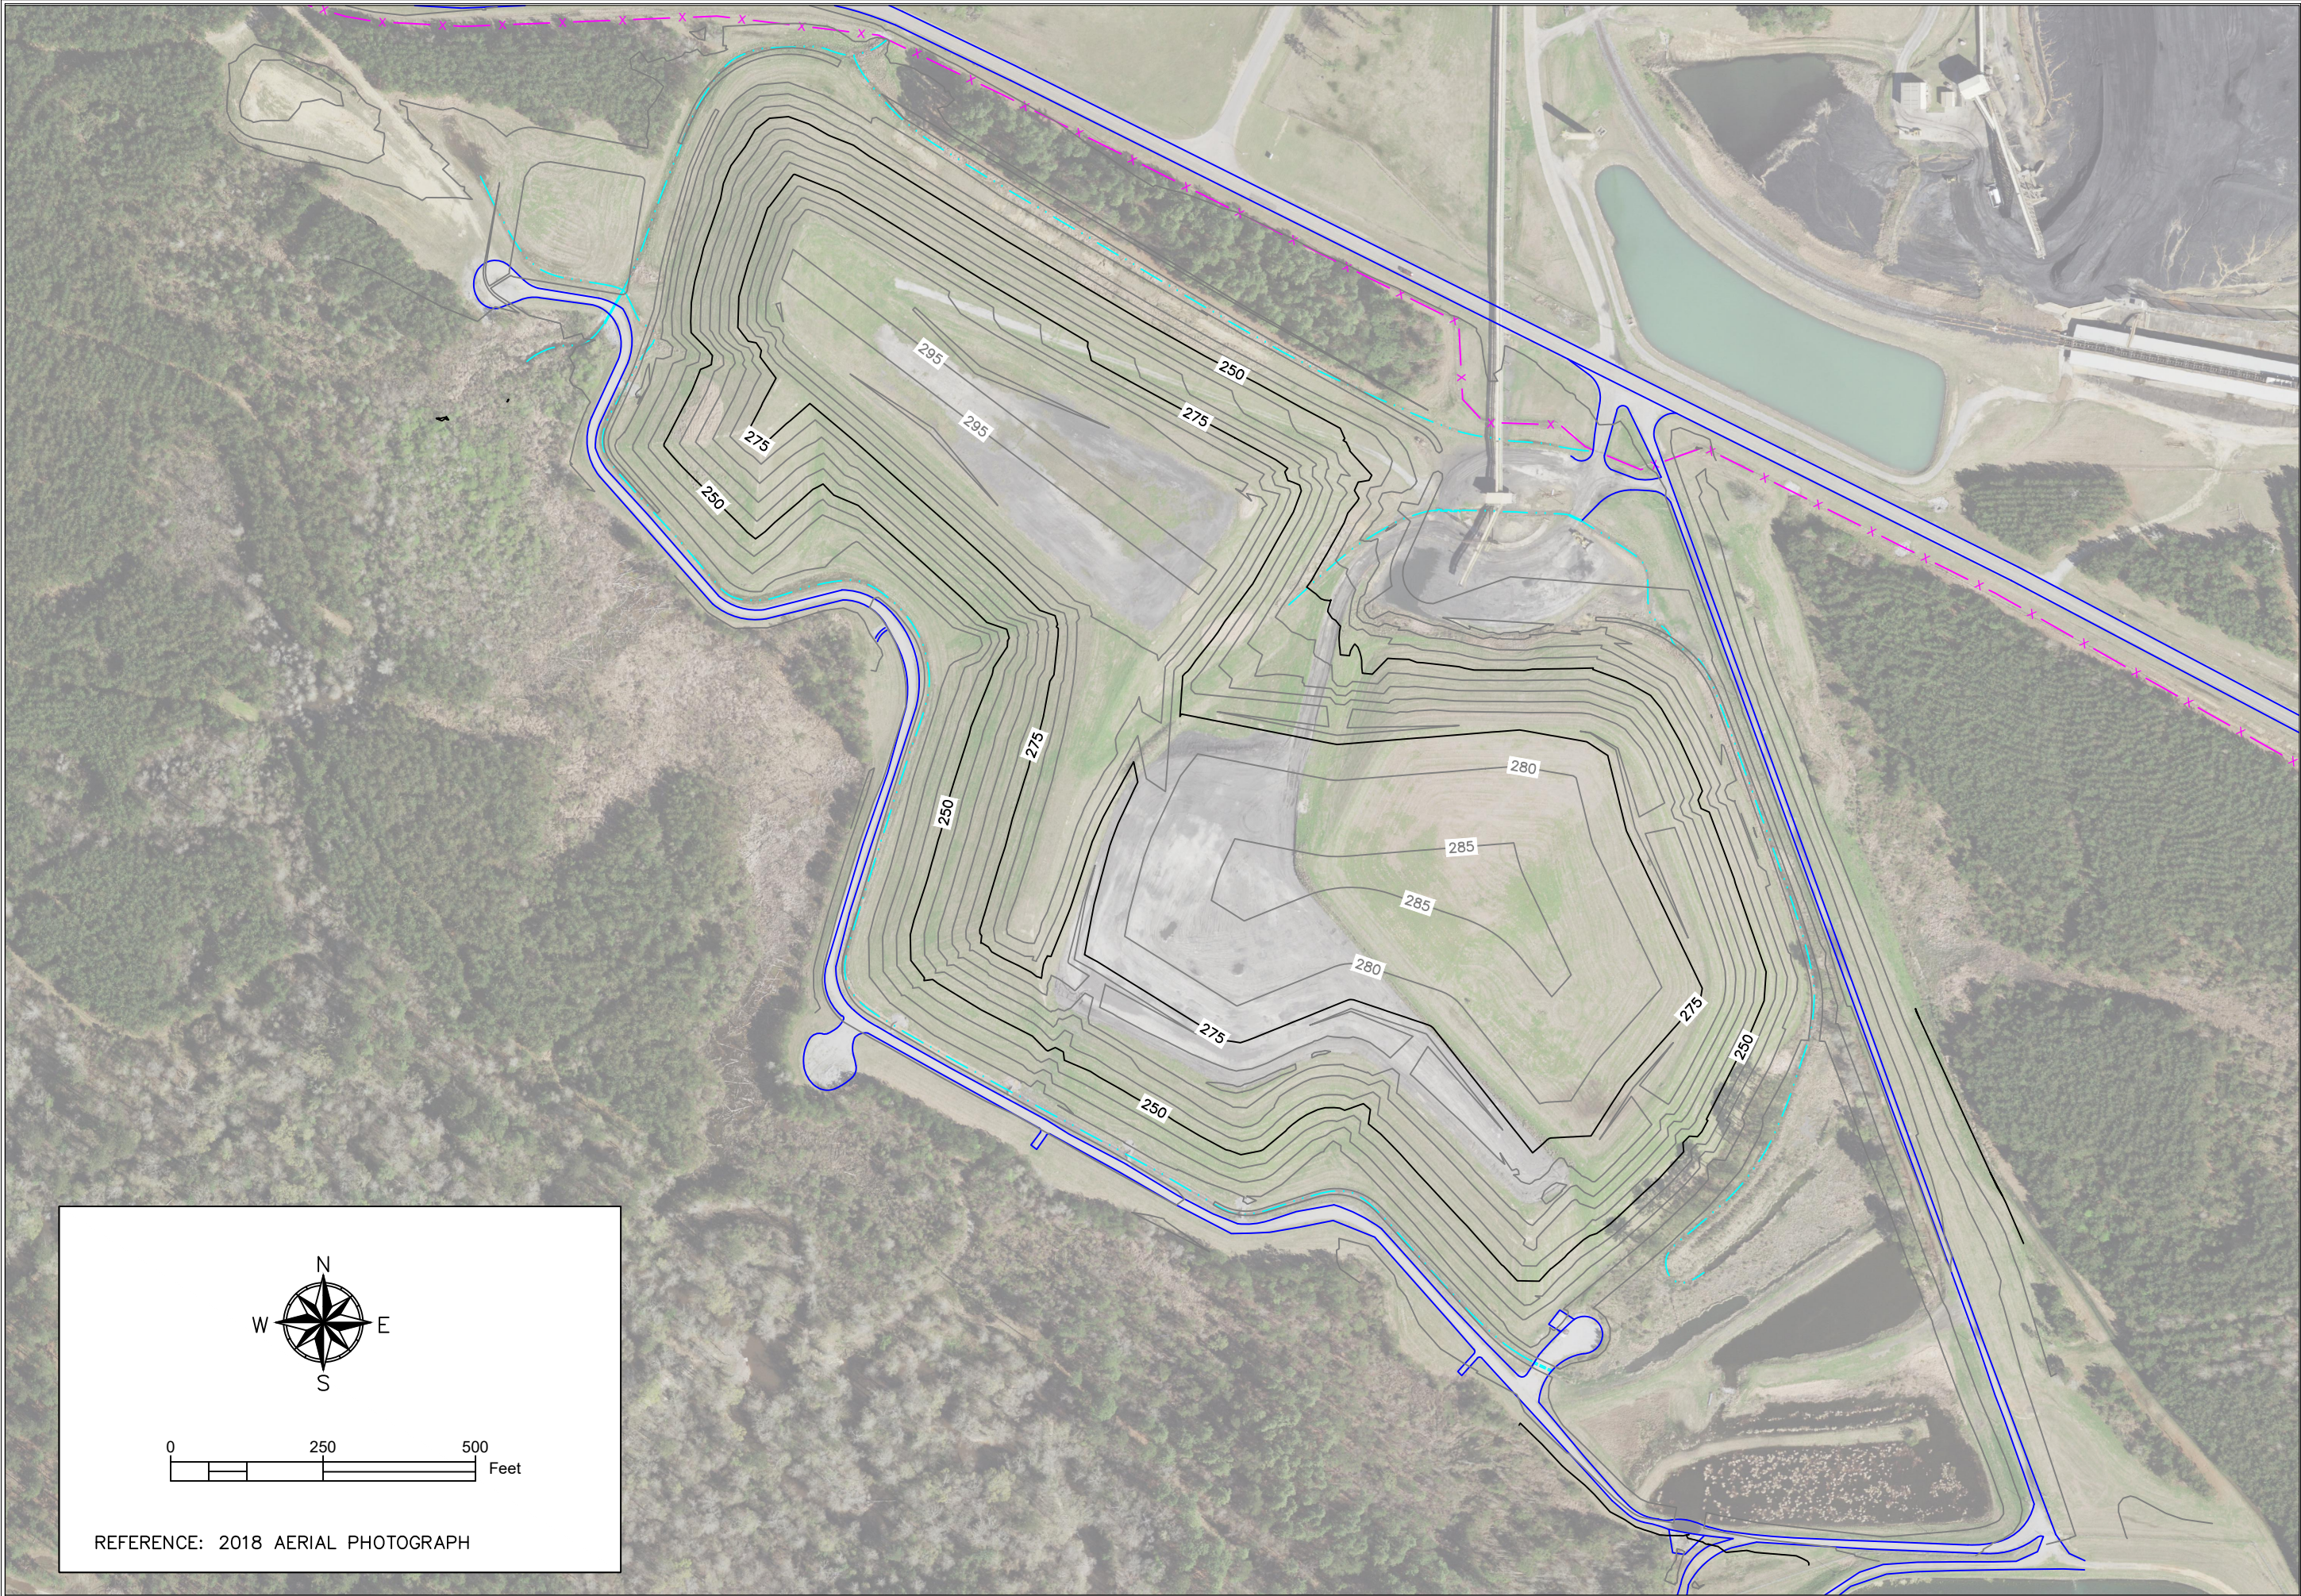
3 OF 5

REFERENCE: 2018 AERIAL PHOTOGRAPH

2018 AERIAL PHOTOGRAPH
R.D. MORROW LANDFILL
PURVIS, MS

- 1 - Site Location Map
- 2 - Landfill Sector Index Map
- 3 - Proposed Final Contour Map
- 4 - Aerial Photograph
- 5 - Landfill Volume Summary
