Re: Annual CCR Landfill Inspection Report for 2021
R.D. Morrow, Sr. Power Generating Station
Purvis, Lamar County, Mississippi

EMS performed the CCR landfill inspection on December 9, 2021. The CCR landfill has been regraded for final closure that included the installation of a synthetic turf grass composite liner cap system. The landfill capping and closure was completed as of the closure record date of October 12, 2021. The review of available existing information, inspection summary, and conclusions regarding changes in landfill geometry, CCR volume, and the structure, operation, stability, and safety of the landfill are summarized herein.

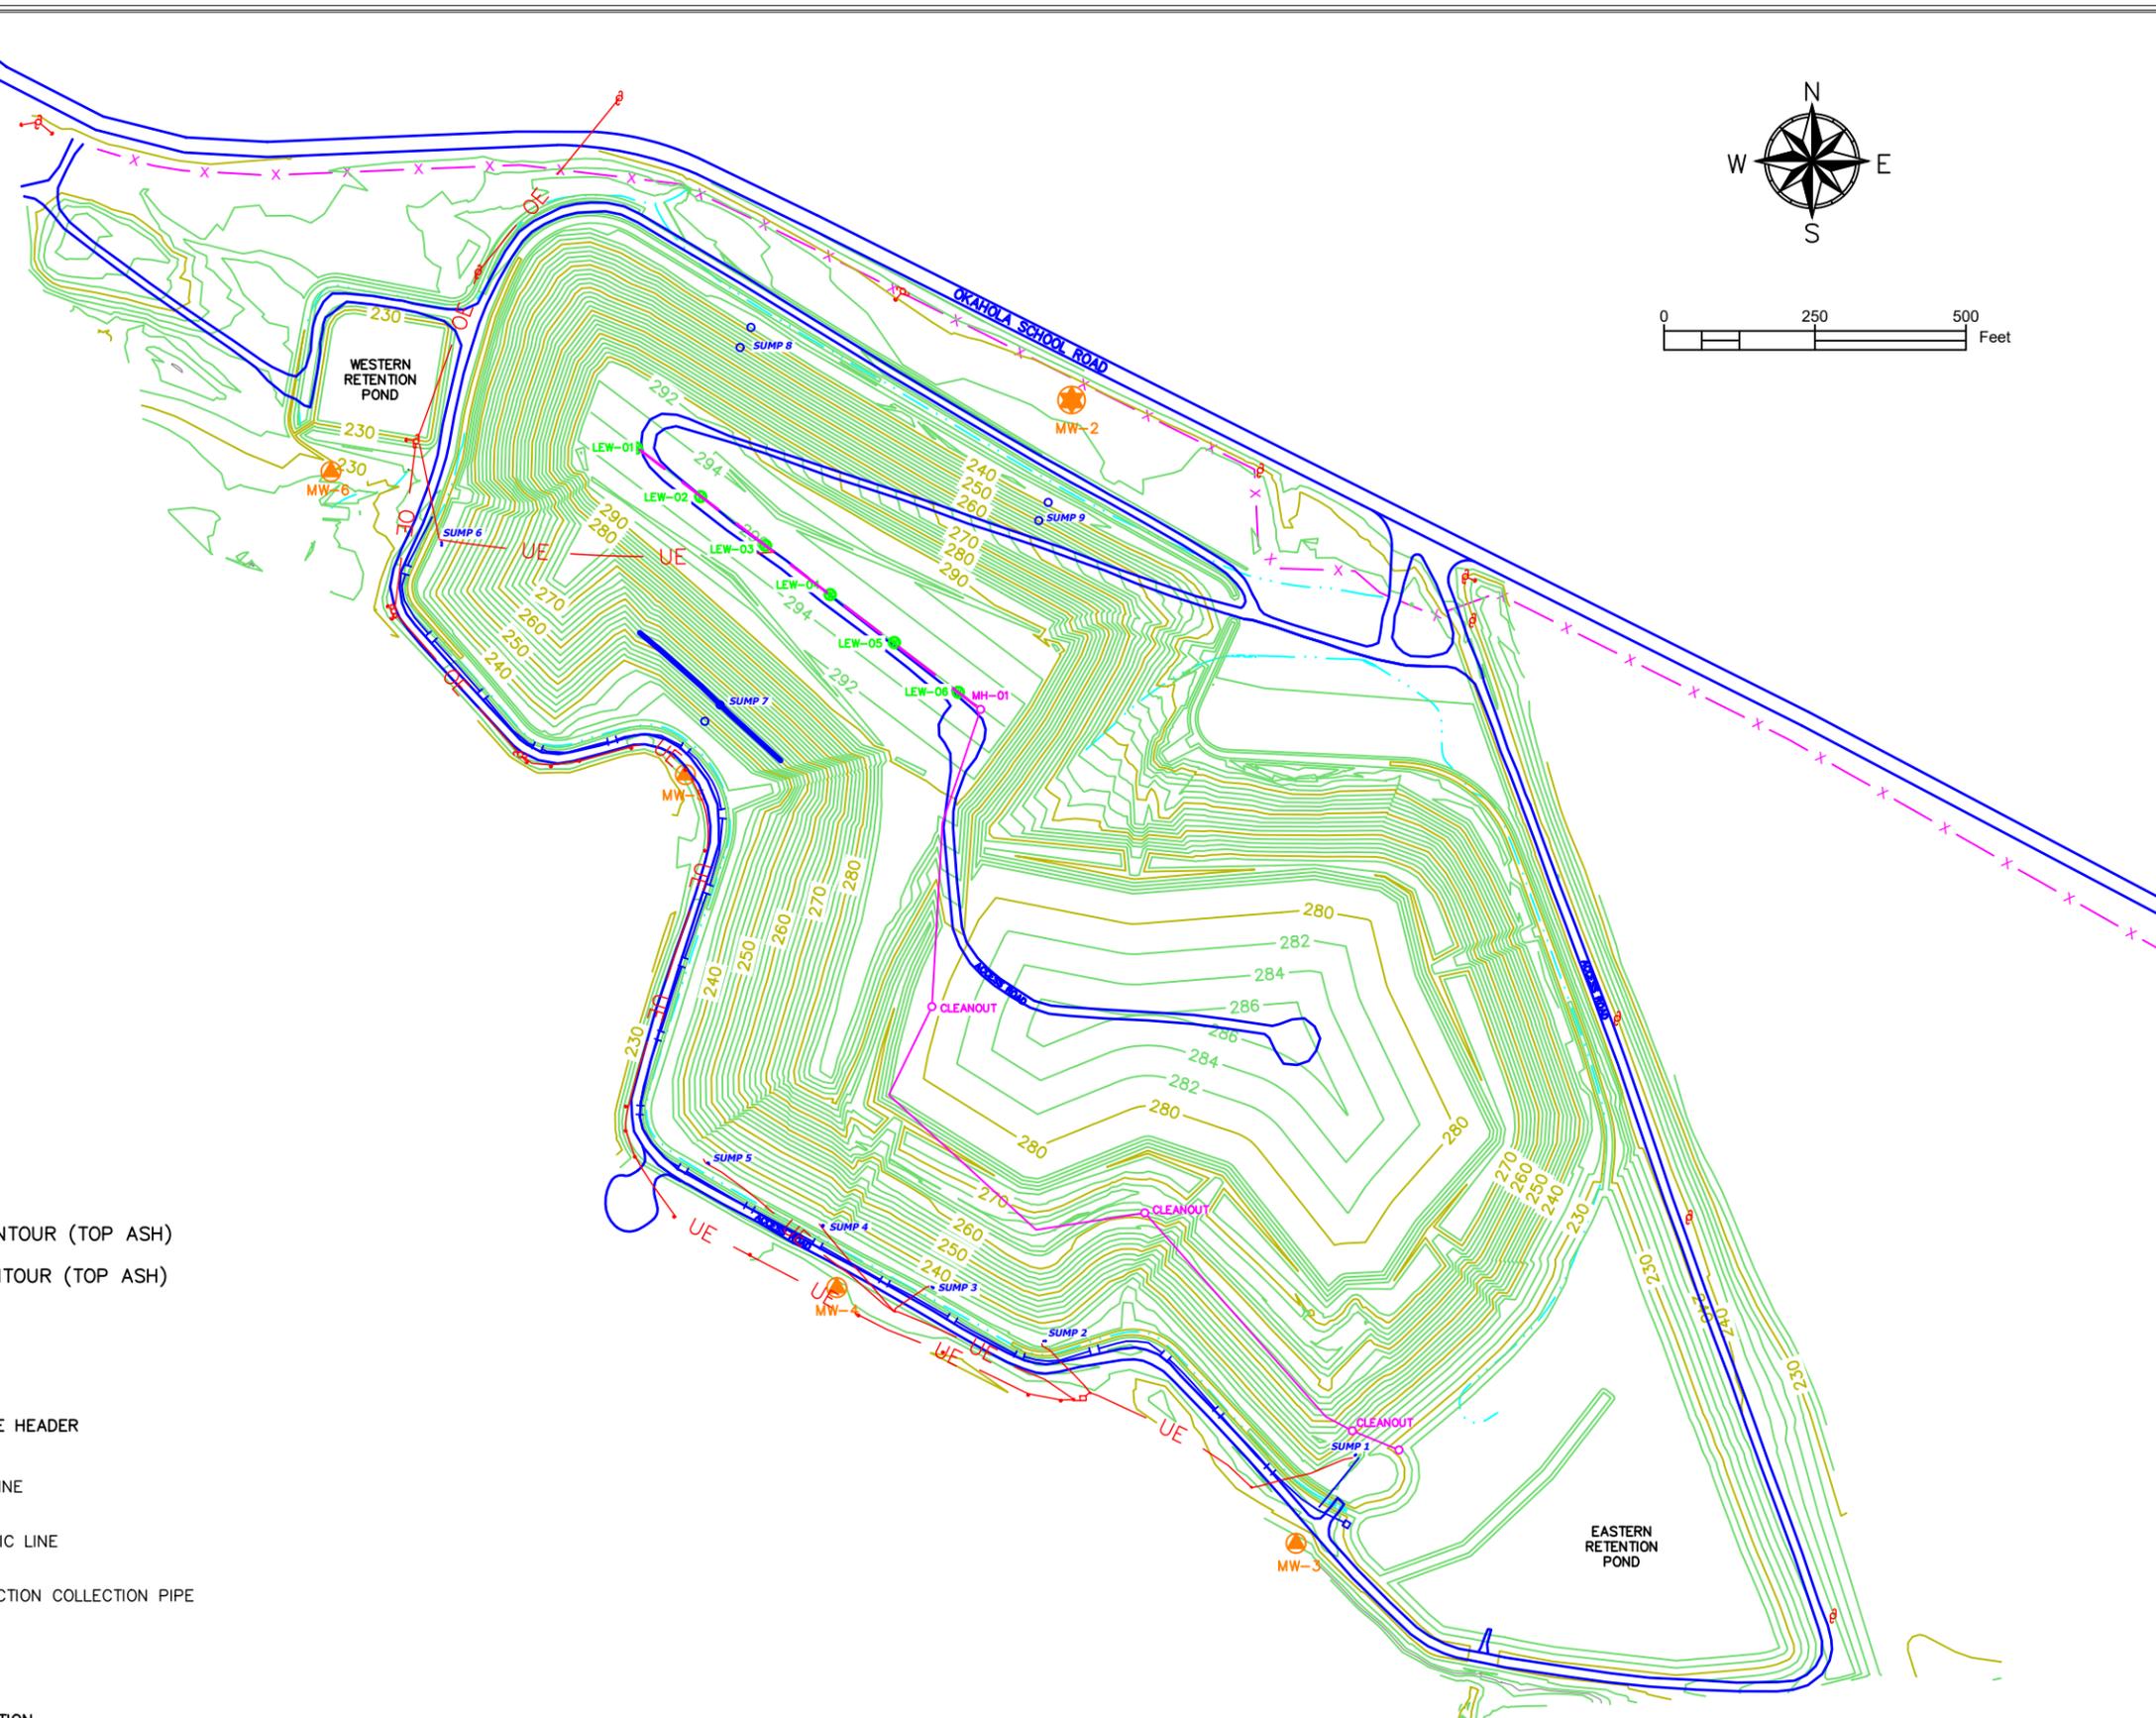
EXISTING SITE PLAN
R.D. MORROW LANDFILL
PURVIS, MS

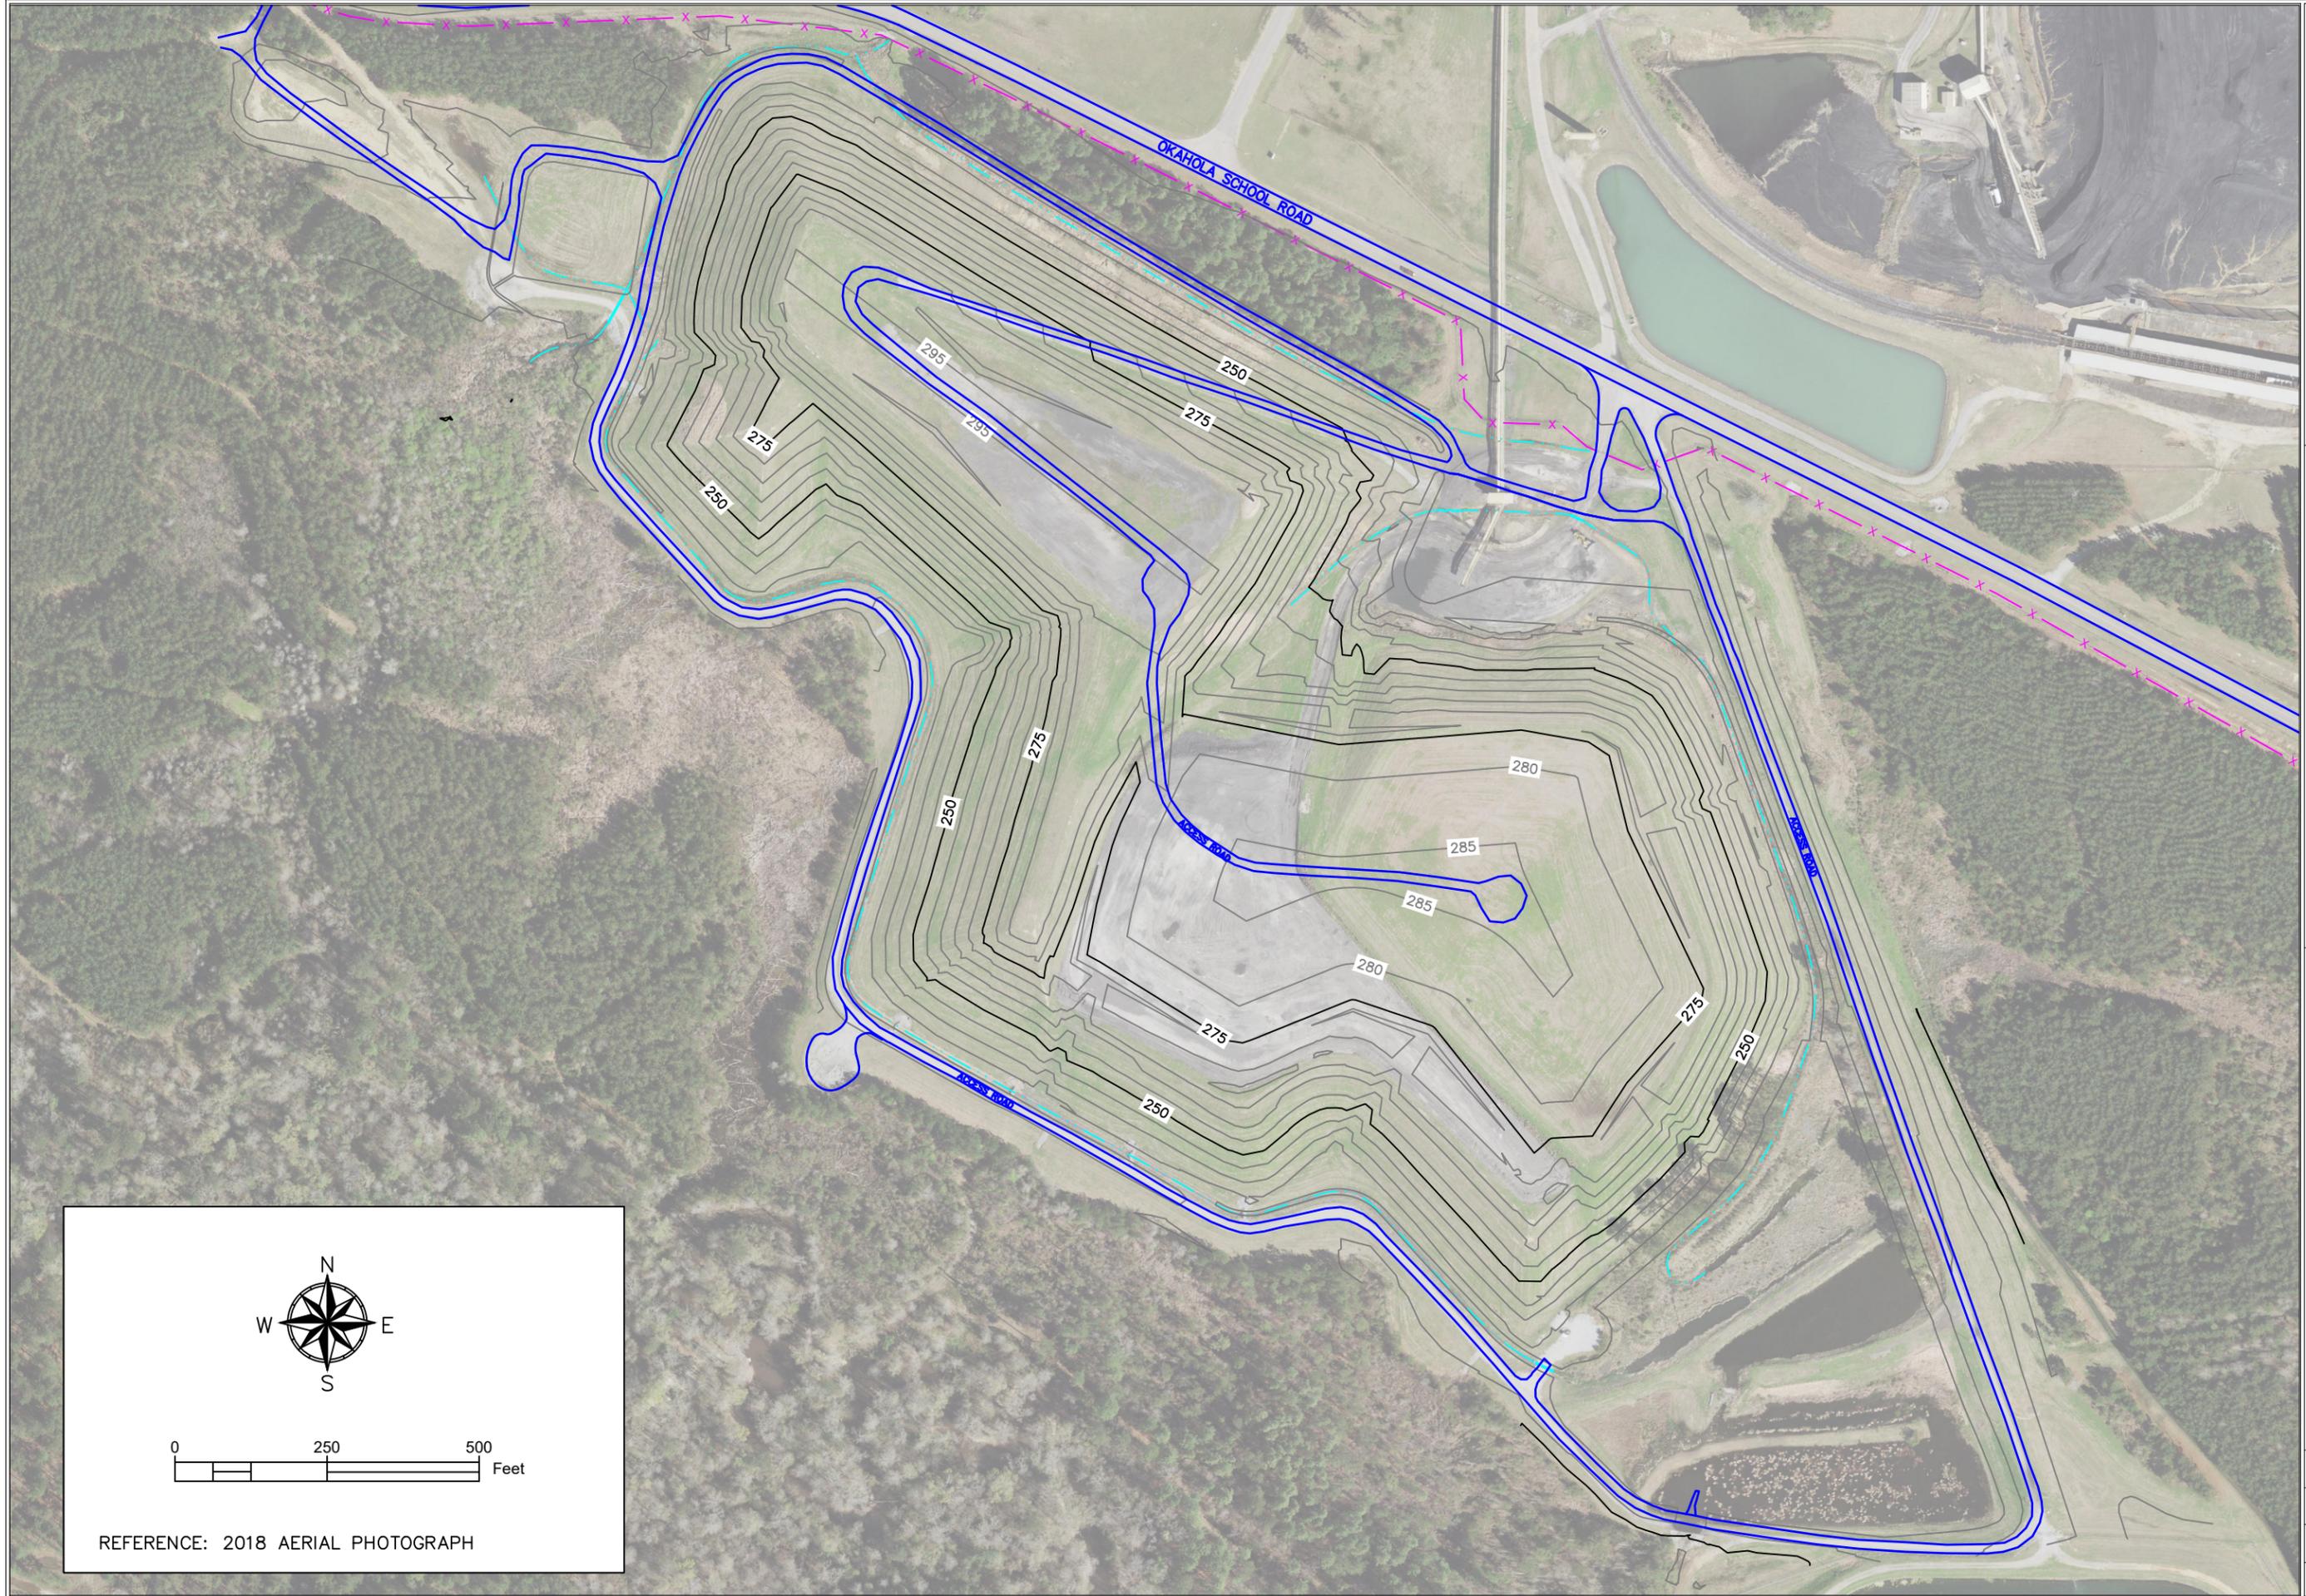
REFERENCE: 2018 AERIAL PHOTOGRAPH

PREPARED FOR
2018 AERIAL PHOTOGRAPH
 R.D. MORROW LANDFILL
 PURVIS, MS
